Home Inspection Report

Prepared for: Sam Wantstosell
Date: 12/15/2014

Property address: 6789 Treehouse Dr.
Summerville SC 29483

Inspected by: Stephen Houmard
Solid Ground Home Inspections
South Carolina License #2046
Certified ASHI® Home Inspector
Infrared-Certified® Home Inspector

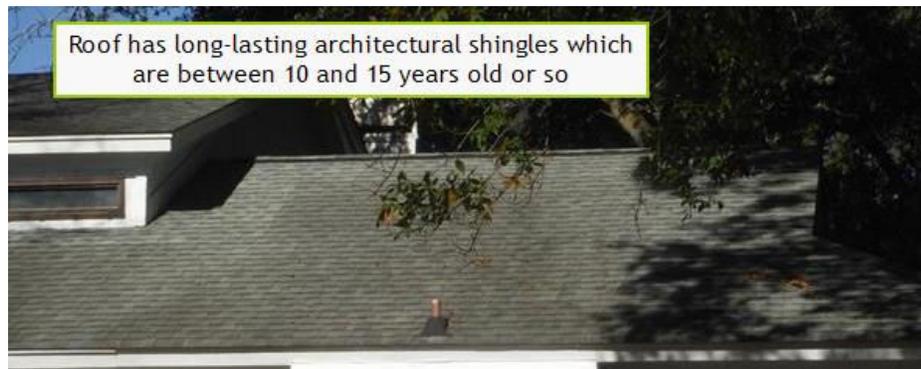
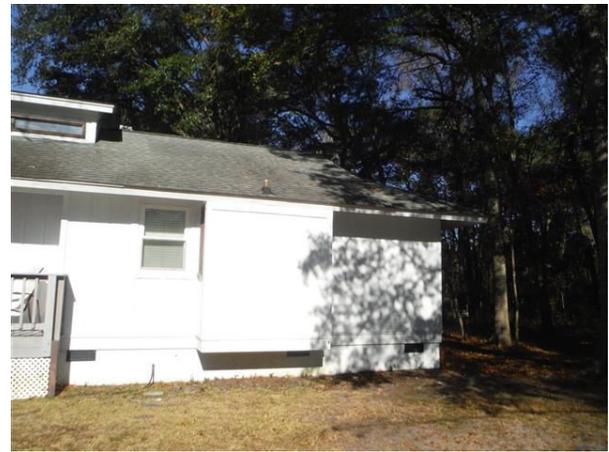
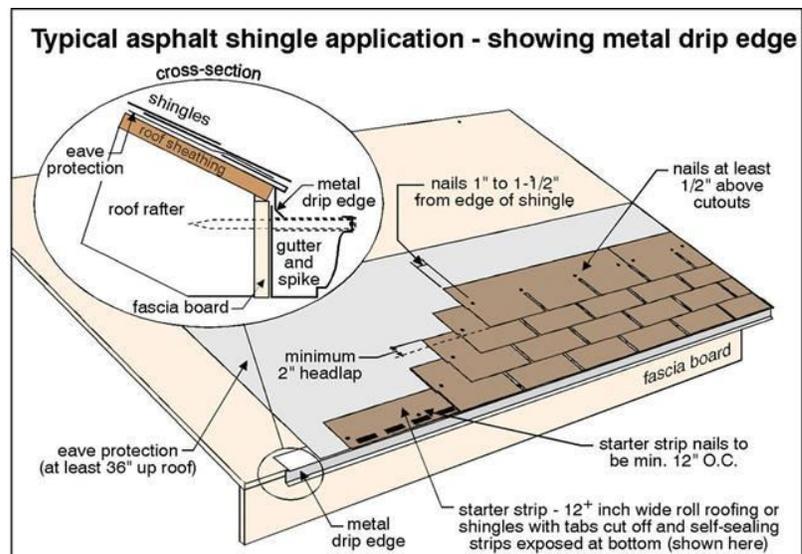
(1) Observed that the roof has long-lasting architectural shingles which are estimated to be about 10 to 15 years old or so. For your reference, the average roof with this type of shingles can last up to 25/30 years and possibly longer depending on the local climate and roof ventilation.

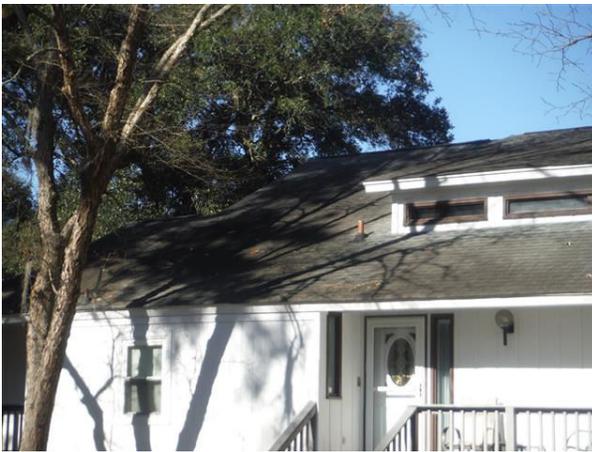
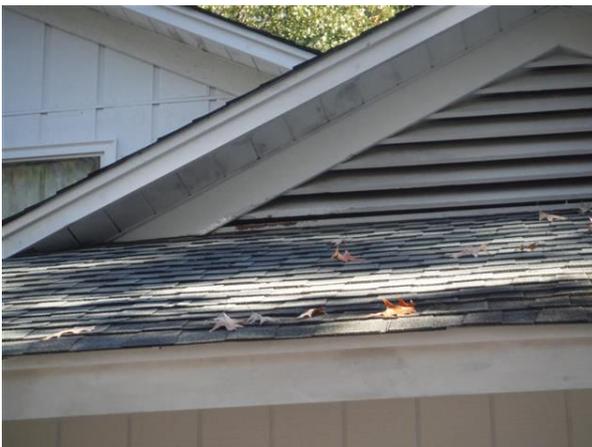
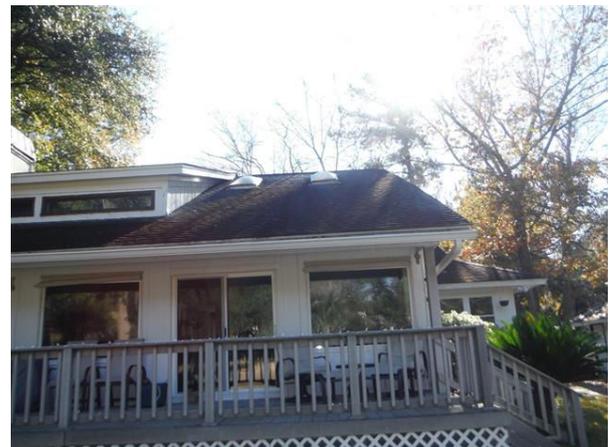
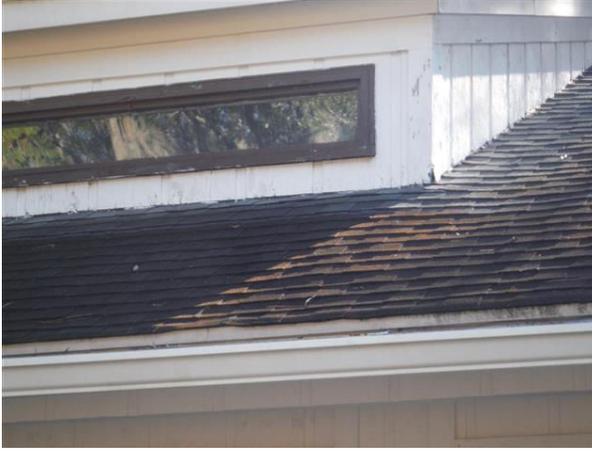
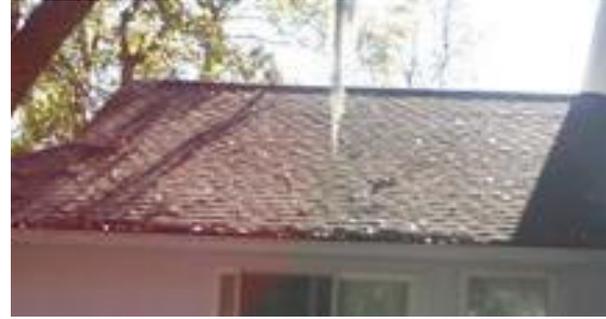
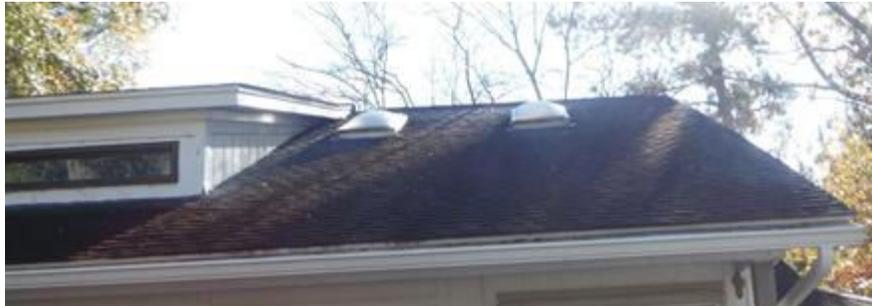
(3) Observed that there is some debris on the roof -- this can cause the shingles to age faster than normal if left over time. Recommend having the debris removed and again periodically, as needed, to help keep the shingles in good shape.

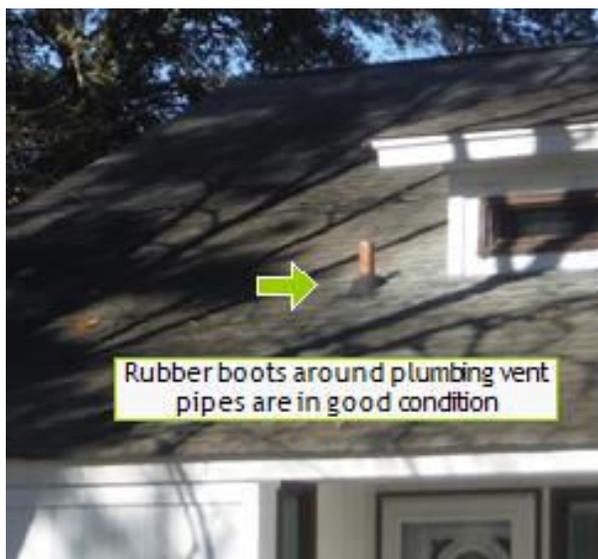
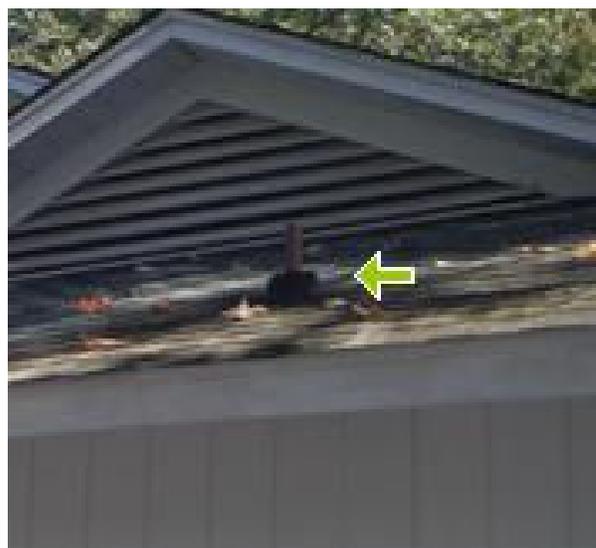
Good to know! Flashing is a sheet of metal which is installed around pipes and chimneys traveling through the roof to ensure these areas are water tight. Also, flashing is applied along the sidewalls where different parts of the roof come together as well.

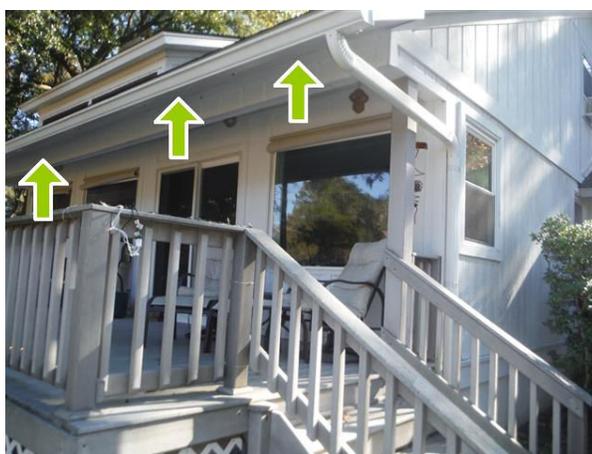
1.2 GUTTERS

(1) Observed that there are gutters on the back of the house. Once you move in, you'll start to notice how the rain drains off your home. In some areas, you may see the water pour down -- these are areas where the water will erode the soil over time or pool next to the foundation (and then seep down into the crawlspace). When you have this information, its a good time to have gutters installed. For your reference, gutters carry water away from the home and foundation which helps prevent damage to the soffits, excess rain water from getting into the crawlspace (which is a space you want to keep as dry as possible), water penetration into the home, mold/mildew growth on the siding and soil erosion. Recommend having gutters installed the rest of the way around the home when you have a chance.

(2) Please note the gutters are full of debris. Recommend having the gutters cleaned so that they work as they should. Then, recommend cleaning your gutters twice year -- ideally in the spring and in the fall.

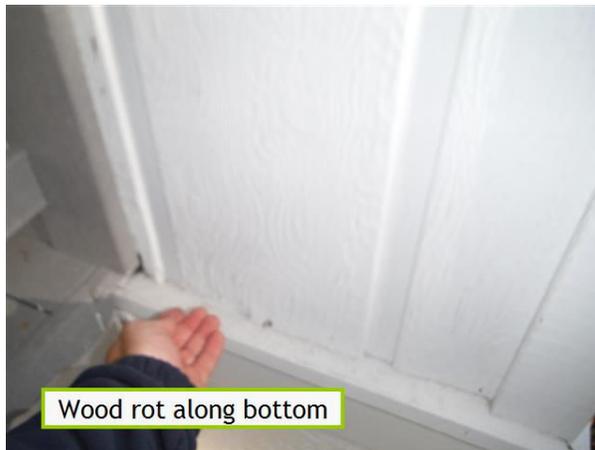
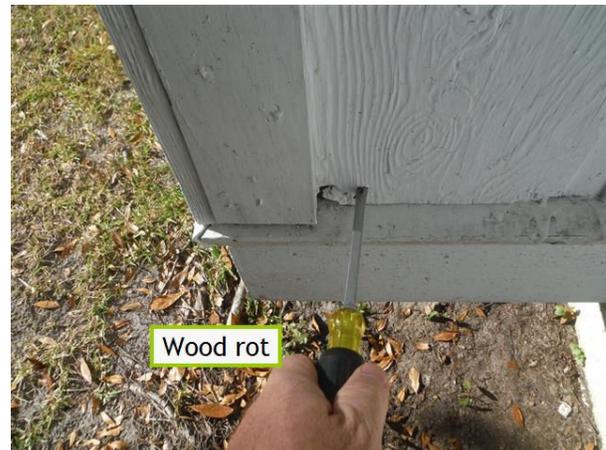
(1) Observed that there is minor wood rot along the bottom of the siding on the front of the home. Also, I was not able to reach and touch every part of the wood on the exterior of this home to assess wood rot. As a result, there may be some areas of the wood siding/fascia/soffit/eaves, etc. in areas out of my reach. Recommend having a contractor or handyman evaluate the siding further to ensure all wood rot has been identified, then repair or replace the wood, where needed, to ensure the siding is again in good condition and water tight.

(1) Observed that there is minor wood rot along the bottom of the siding on the front of the home. Also, I was not able to reach and touch every part of the wood on the exterior of this home to assess wood rot. As a result, there may be some areas of the wood siding/fascia/soffit/eaves, etc. in areas out of my reach. Recommend having a contractor or handyman evaluate the siding further to ensure all wood rot has been identified, then repair or replace the wood, where needed, to ensure the siding is again in good condition and water tight.

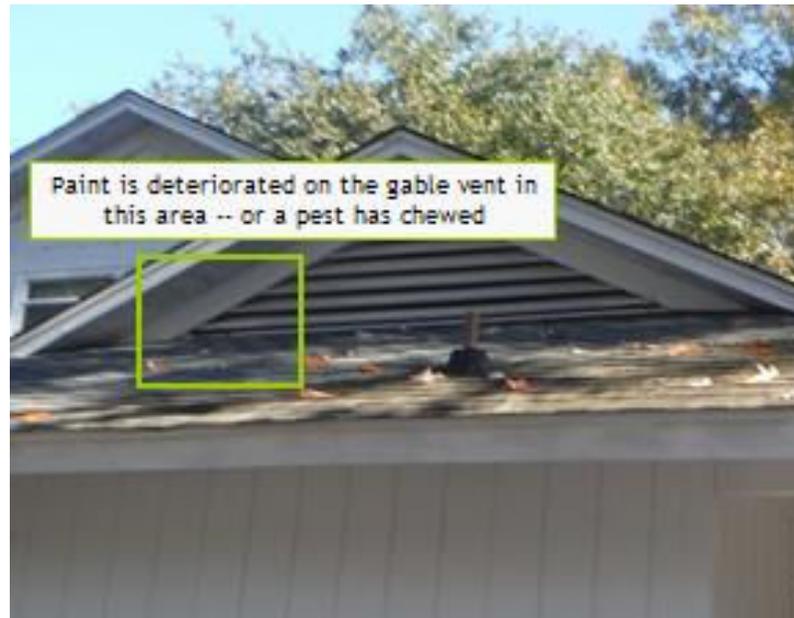
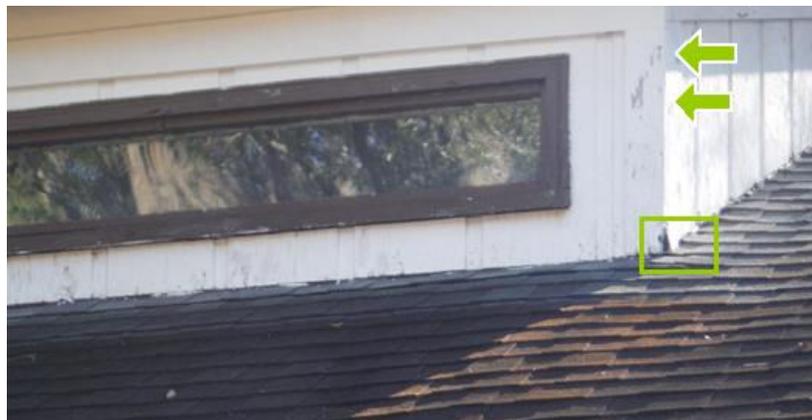
(3) Observed that some of the paint for the siding, trim, railings, door and window frames, soffits or fascia and gable vent around the home is deteriorated -- this exposes the wood to moisture which can lead to wood rot. Recommend having all exterior wood components (siding, trim, door and window frames, railings, fascia/soffits, etc). painted to protect the wood from the weather and wood rot.

(3) Observed that some of the paint for the siding, trim, railings, door and window frames, soffits or fascia and gable vent around the home is deteriorated -- this exposes the wood to moisture which can lead to wood rot. Recommend having all exterior wood components (siding, trim, door and window frames, railings, fascia/soffits, etc). painted to protect the wood from the weather and wood rot.

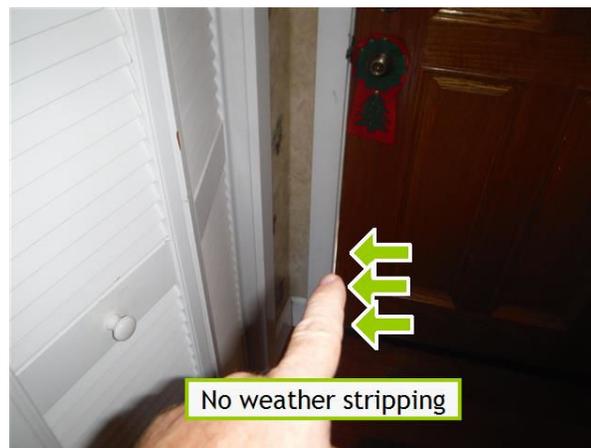
(1) Observed that the back door does not have weather stripping all the way down. Recommend having a handyman install weather stripping around this door so it is weather tight and for energy savings.

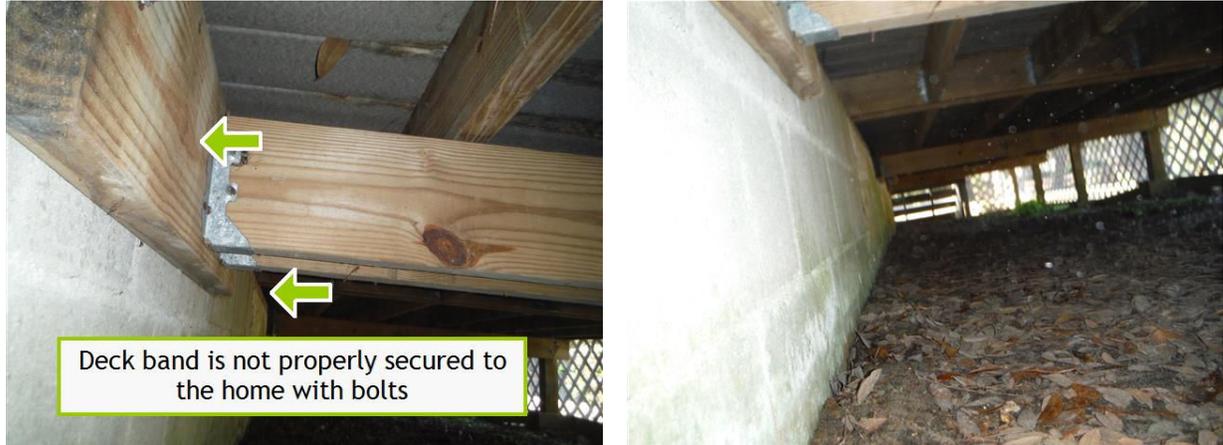
(1) Observed that the deck band is not attached securely to the home. Instead, the deck should be attached with 5/8" galvanized lag screws or carriage bolts about every 36". Recommend having a contractor properly secure the deck to the home, for safety.

(1) Observed that the deck band is not attached securely to the home. Instead, the deck should be attached with 5/8" galvanized lag screws or carriage bolts about every 36". Recommend having a contractor properly secure the deck to the home, for safety.

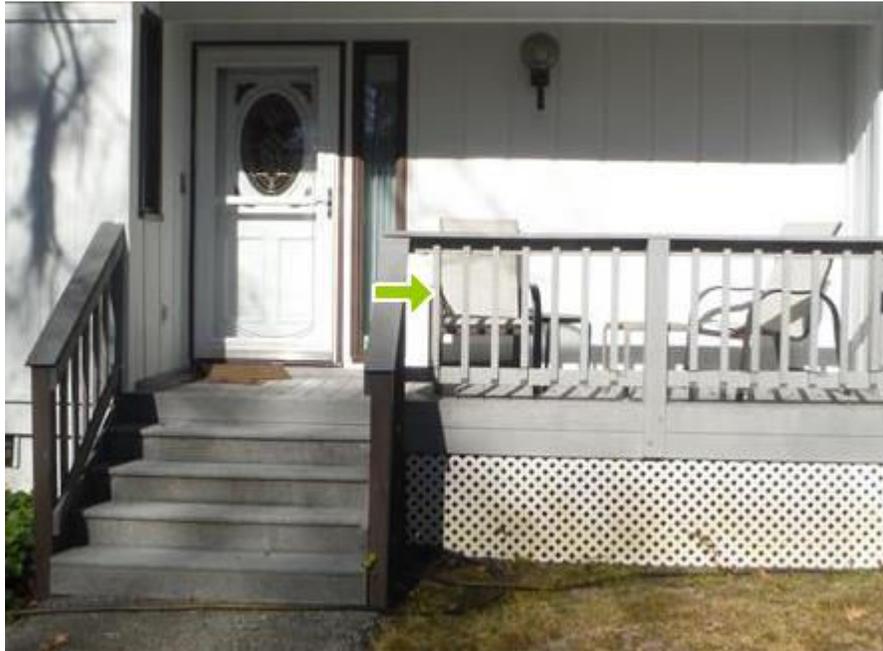
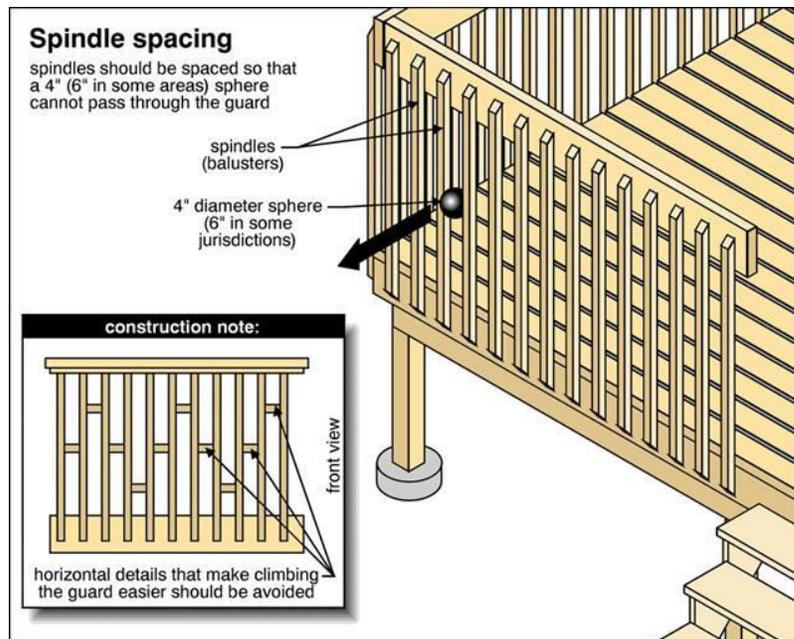
(2) Observed that the spindles/pickets for the front porch railing and for the deck railing on the back of the home are spaced more than 4" apart -- this is a safety concern because it could cause a small child or pet to slip through or get stuck in between. If you have a small child or pet, recommend having a contractor or handyman adjust the spindles so that there is no more than 4" between them, for safety.

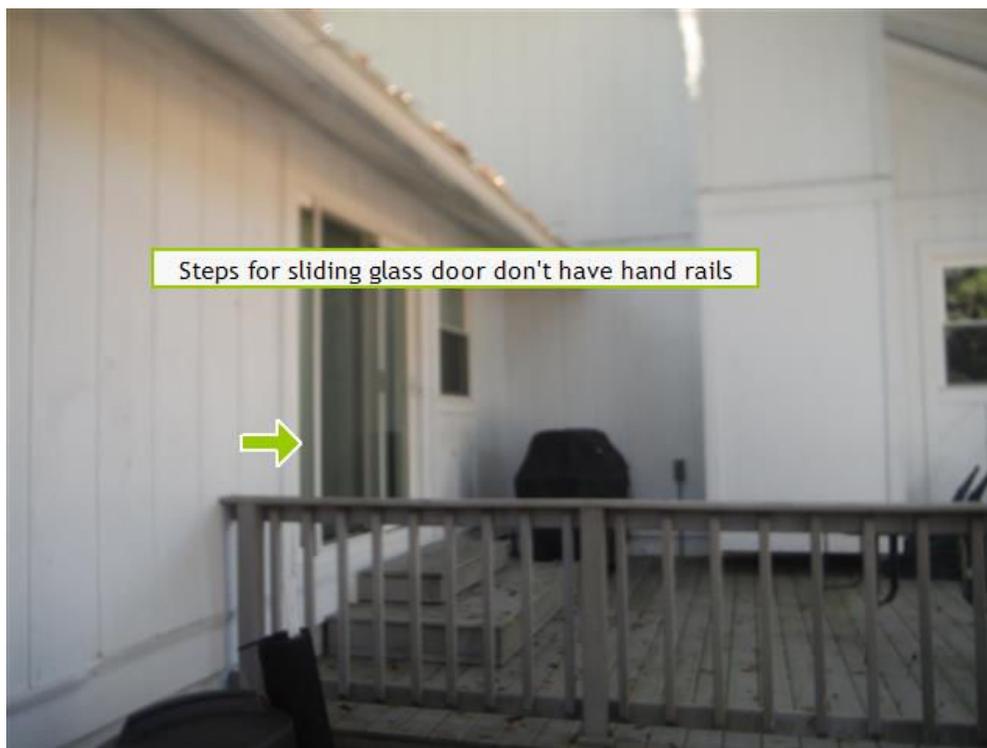
(3) Observed that the steps for the sliding glass door don't have hand rails on either side -- this may be a safety concern if you have small children. If so, recommend having a handyman or contractor install hand rails on either side of the door with spindles that are no more than 4" apart, for safety.

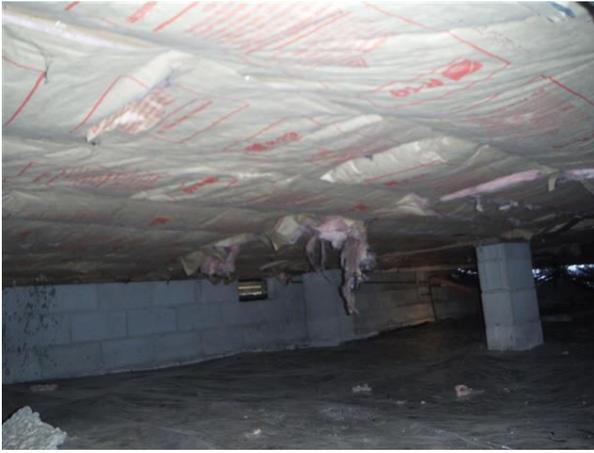
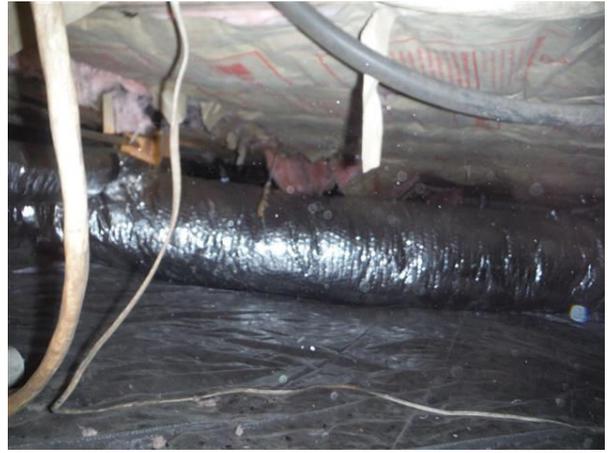
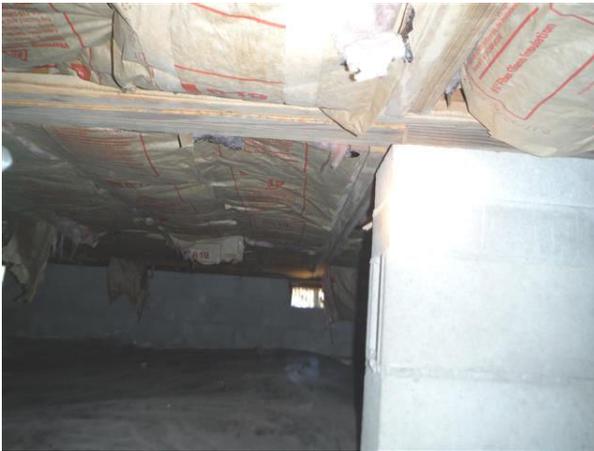
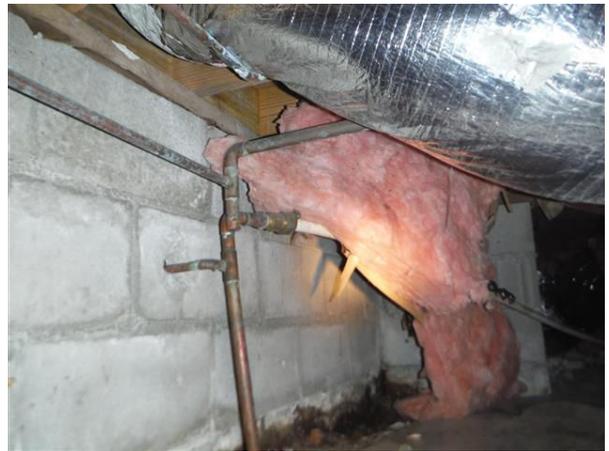
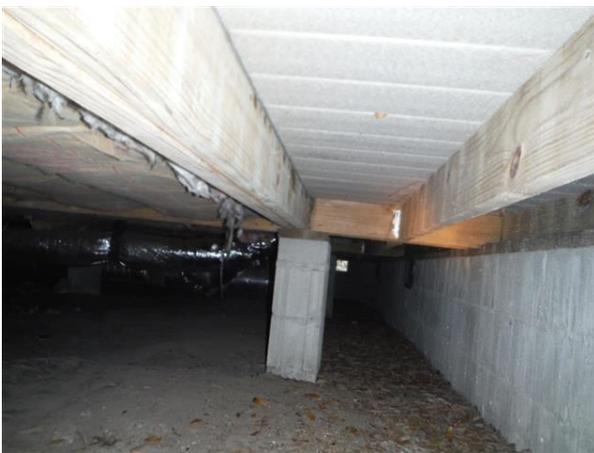
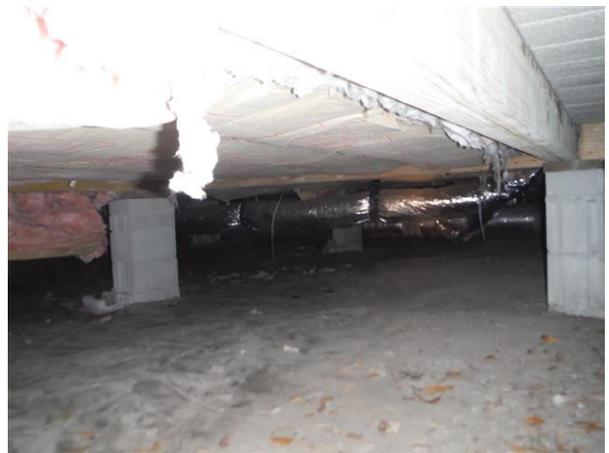
Observed that this home's foundation is a system of cement block piers and has a cement block skirting (wall) which encloses the crawlspace.

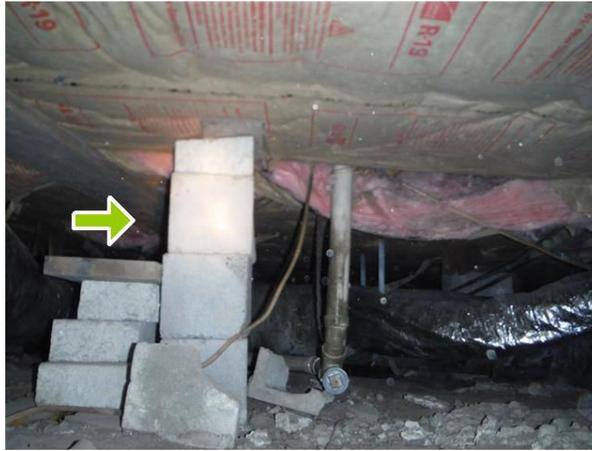
(1) As viewed from inside the crawlspace, observed that there is an old repair to the floor under the kitchen sink. Please note there is a stack of blocks and bricks used to help support this area of the floor. Recommend having a contractor properly install the supports to ensure the blocks are strong and sturdy as they need to be.

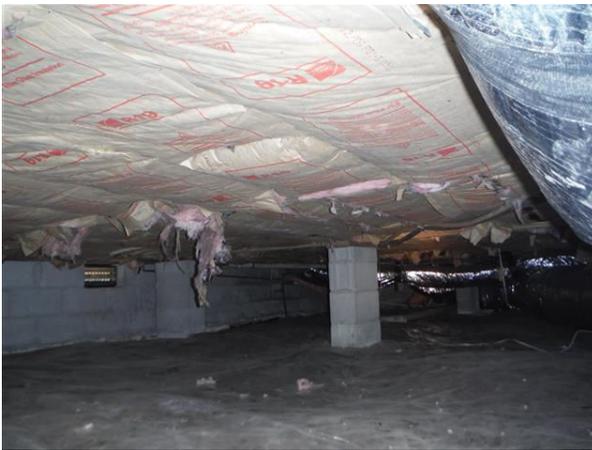
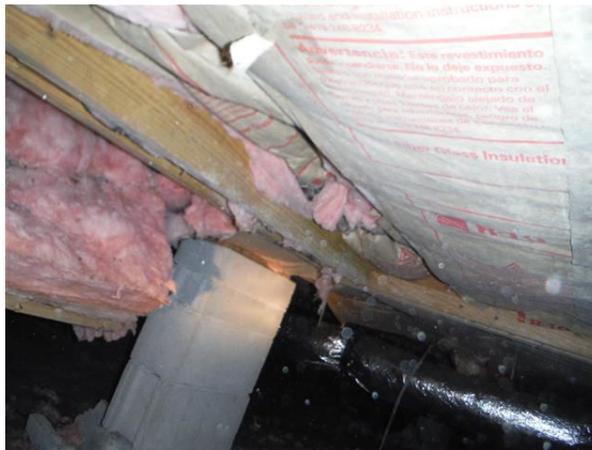
(2) Observed that the piers are in good condition. *Good to know! Columns/piers are an important structural component of the foundation. Their purpose is to transfer loads from beams down through the footings to the soil.*

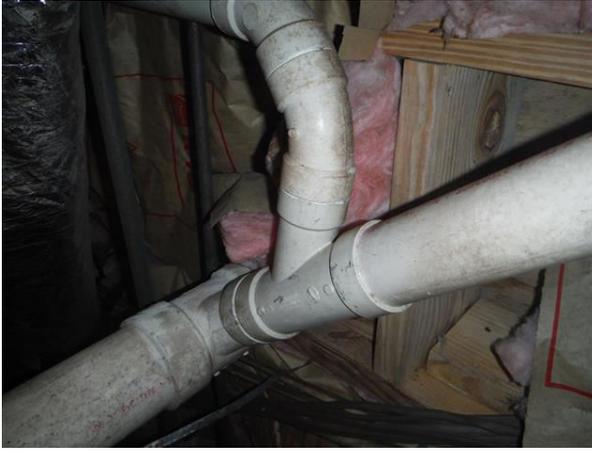
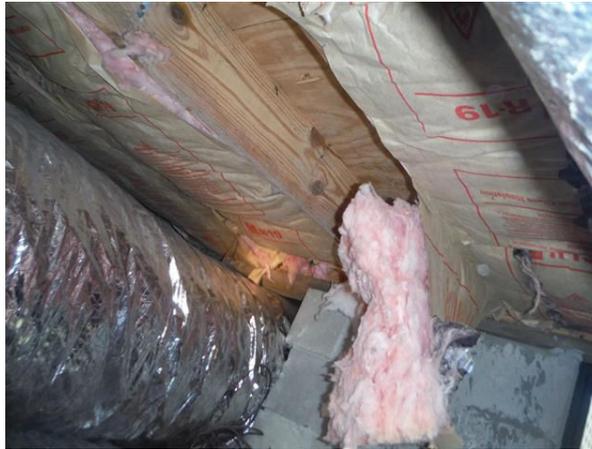
3.2 FLOORS (Structural)

As viewed from inside the crawlspace, the wood (sub-floor and floor joists) around the plumbing pipes is in good condition.

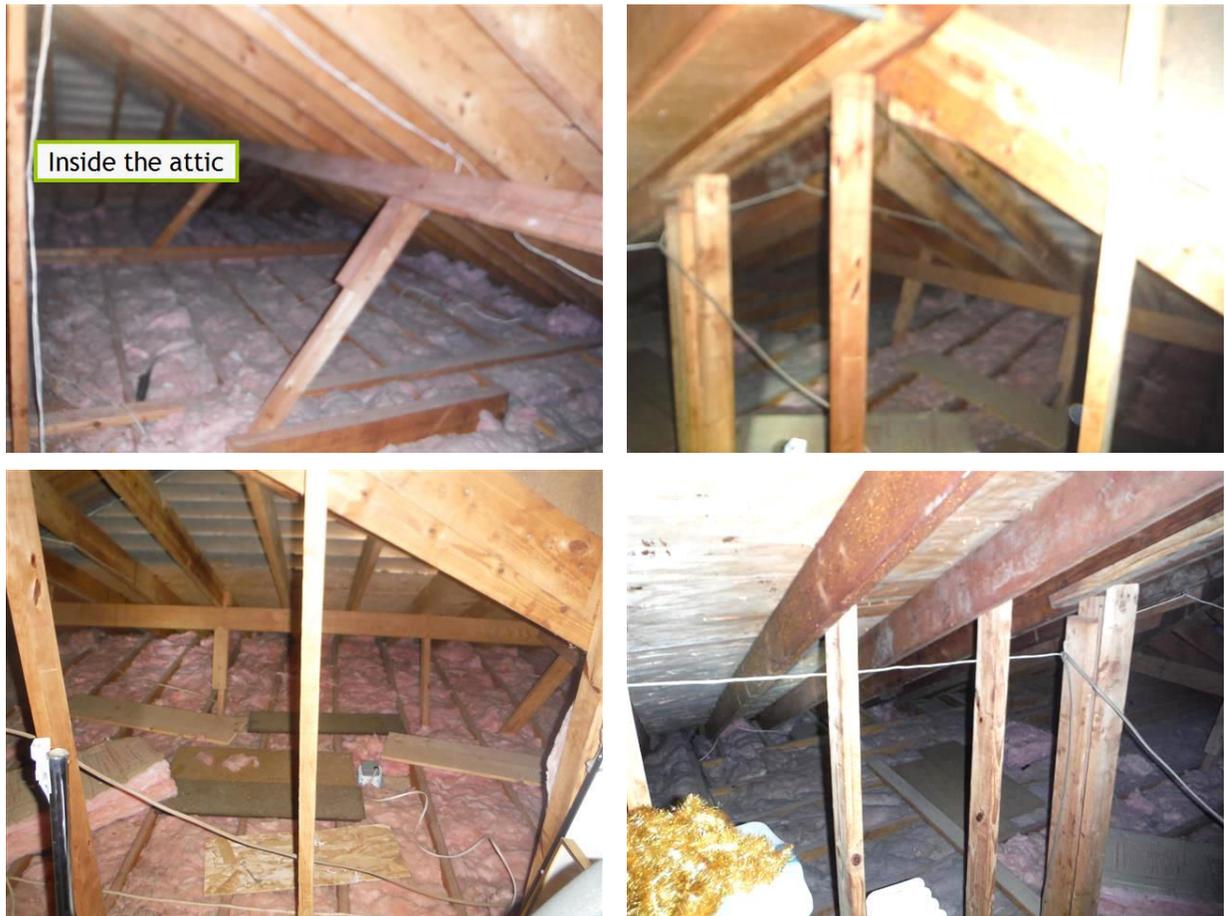
Observed that the roof has a traditional stick built structure with a common board.

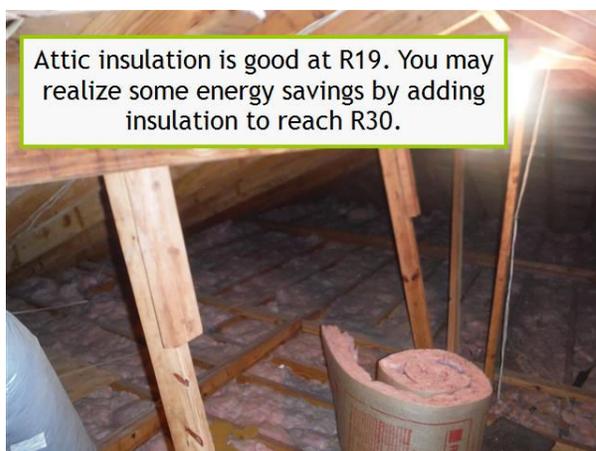
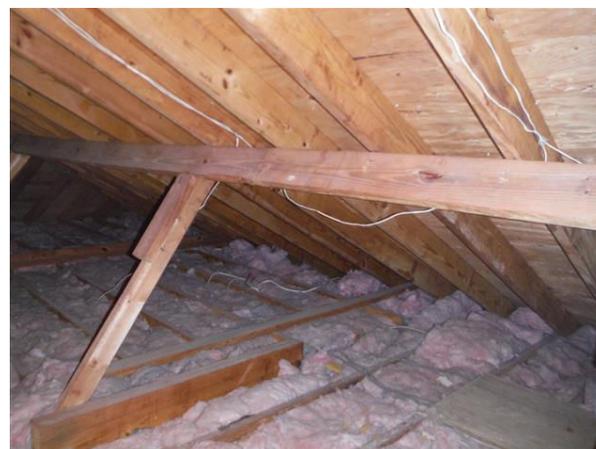
(1) Observed that this home has an amount of insulation on the attic floor which equates to R-19 -- very common for a home of this age. To maximize energy efficiency of the home, recommend having a contractor install additional insulation to reach R-30 or better. For your reference, the effectiveness of insulation is measured by its R-number which is its ability to resist the flow of heat. The higher the R-number, the greater the resistance to winter heat loss or summer heat gain. Today's standard for insulation in newer homes is R-30 or better.

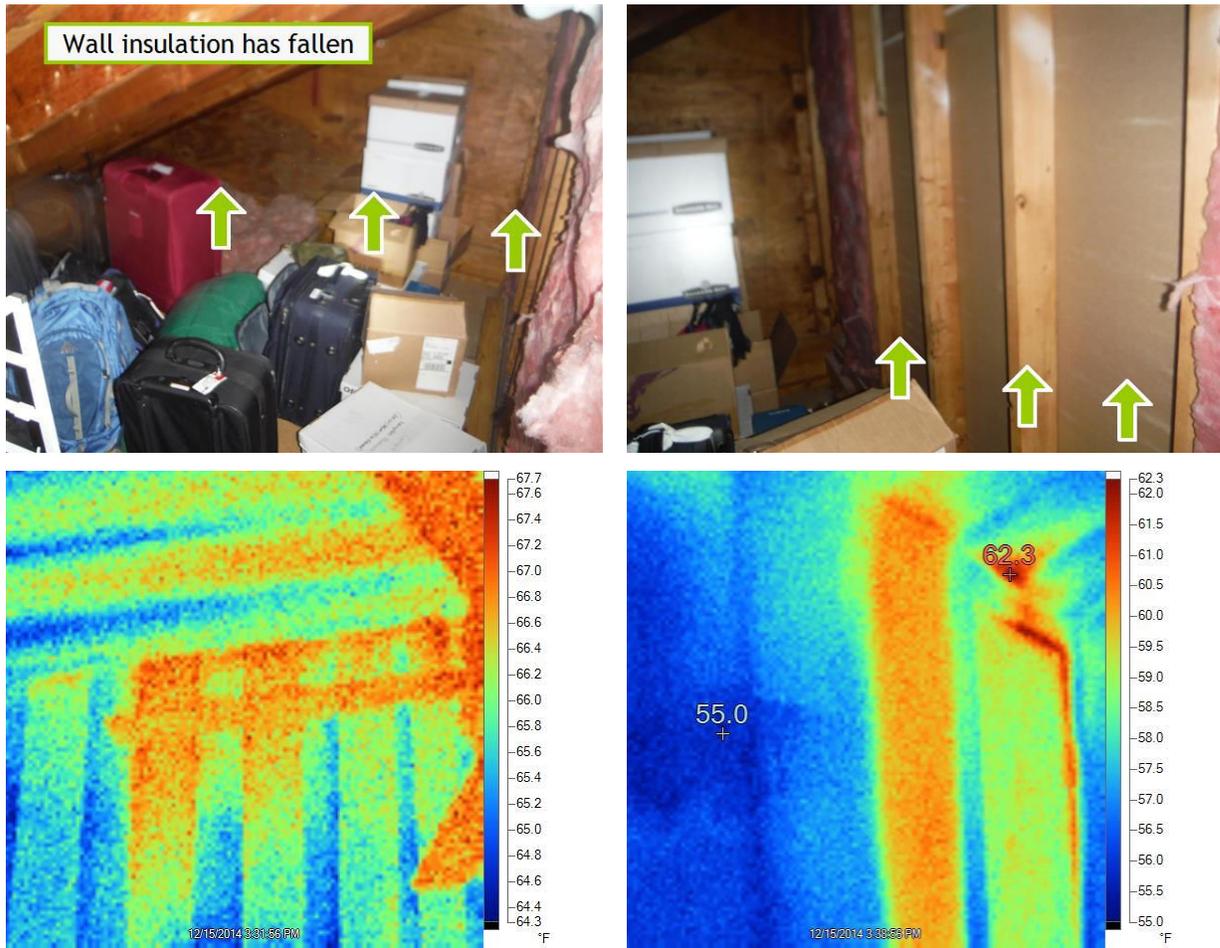
(2) Observed that some of the insulation on the walls in the attic has fallen. Recommend having an insulation contractor or handyman rehang the insulation, for energy savings.

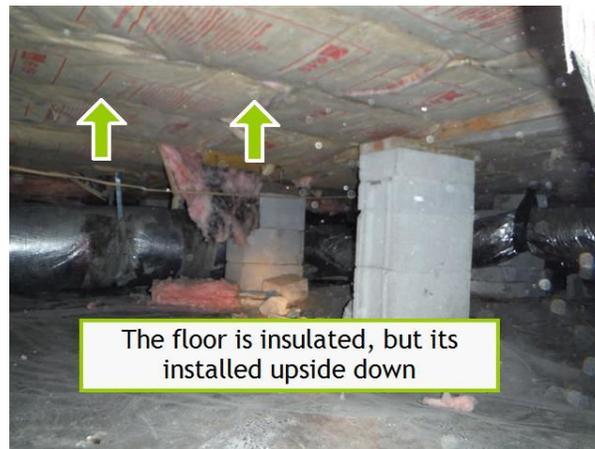
(1) Observed that the floor system is insulated -- a positive. Up to 25% of energy can be lost through a non-insulated floor.

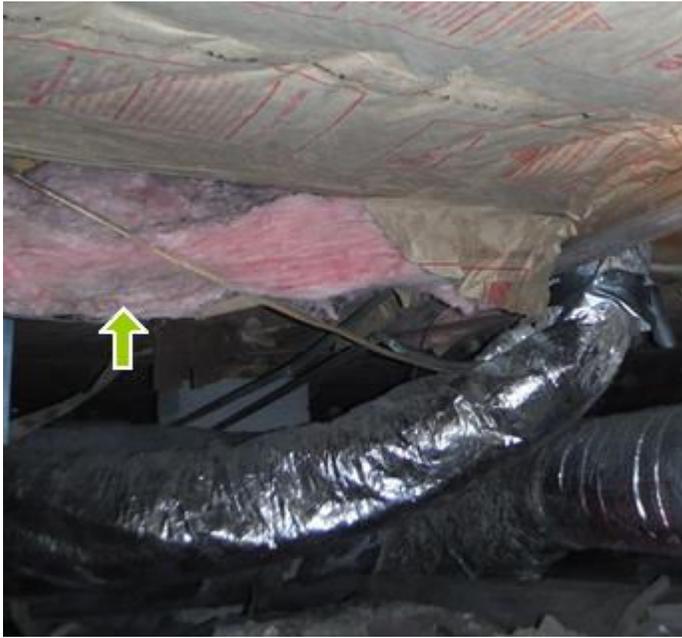
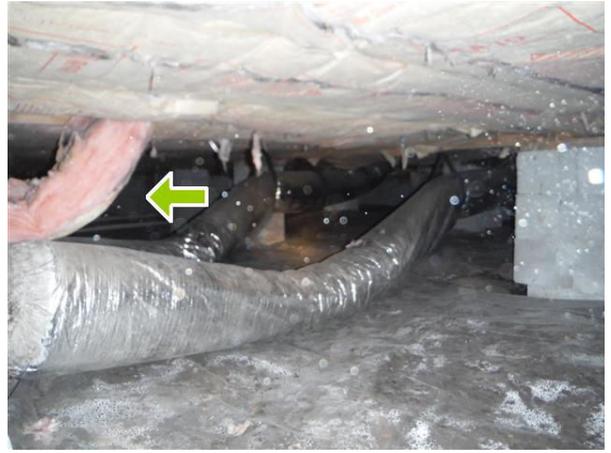
(3) Observed that one or more sections of insulation under the floor in the crawlspace is falling due to humidity. For your reference, insulation which is hanging down acts as a curtain and blocks the flow of air through the crawlspace, thus reducing ventilation. Again, ventilation is important to help keep the crawlspace as dry as possible to preserve the structural integrity of the wood and masonry components which comprise the foundation. Recommend having an insulation contractor or handyman remove the moist insulation to promote good air flow and installing new insulation in its place, as desired.

(3) Observed that one or more sections of insulation under the floor in the crawlspace is falling due to humidity. For your reference, insulation which is hanging down acts as a curtain and blocks the flow of air through the crawlspace, thus reducing ventilation. Again, ventilation is important to help keep the crawlspace as dry as possible to preserve the structural integrity of the wood and masonry components which comprise the foundation. Recommend having an insulation contractor or handyman remove the moist insulation to promote good air flow and installing new insulation in its place, as desired.

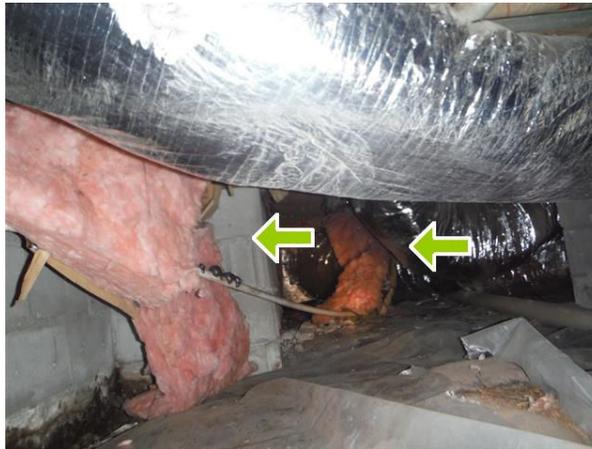
(2) As viewed from inside the crawlspace, observed that some of the wall and ceiling insulation is installed upside down/backwards -- this can trap moisture against the wood which can deteriorate it over time. Instead, the paper side should be attached to the wall/ceiling and the insulation should be visible. Recommend having an insulation contractor or handyman remove and re-install the insulation to help keep the wood in good shape.

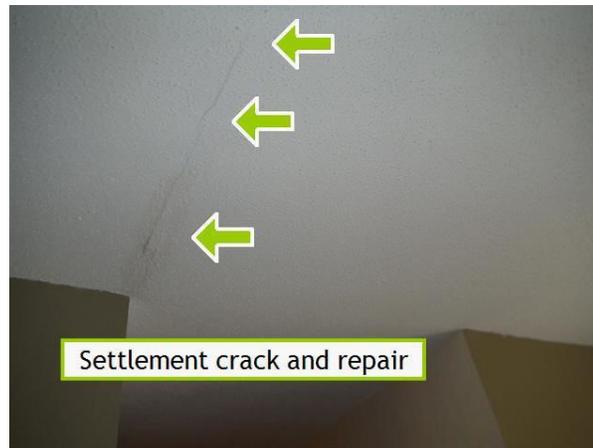
(1) Observed that there is a settlement crack and repair to the ceiling in the hallway. Upon inspection, there does not appear to be any other indications of unusual settlement (which might indicate an issue with the home's structural integrity). Recommend having a contractor or handyman repair the crack(s) so that the drywall is again in good condition. Then, recommend monitoring the crack over time. If it changes in width or length, the crack will need to be repaired again. Also, new cracking or re-cracking may be cosmetic in nature or could indicate continued movement in an area. *As a result, you may want to consider having a structural engineer evaluate the structural significance of any existing cracks further before closing because foundation repairs can be expensive.*

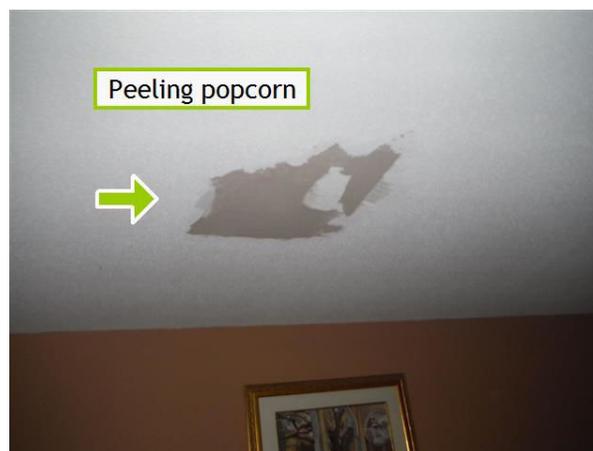
(2) Observed that some of the popcorn has come off the ceiling in the master bedroom -- this can be due to moisture. However when tested with a moisture meter and infrared camera, this area is dry. Recommend repair.

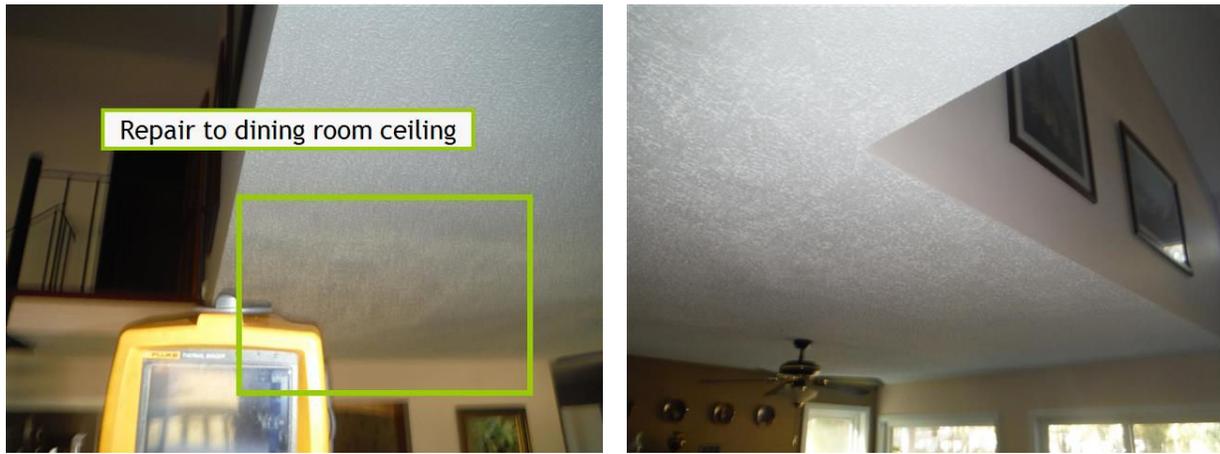
(3) Observed that there is a repair to the ceiling in the dining room. When tested with a moisture meter and scanned with the IR camera, there are no indications of an active leak at this time. Repairs appear to be sufficient. This is an fyi.

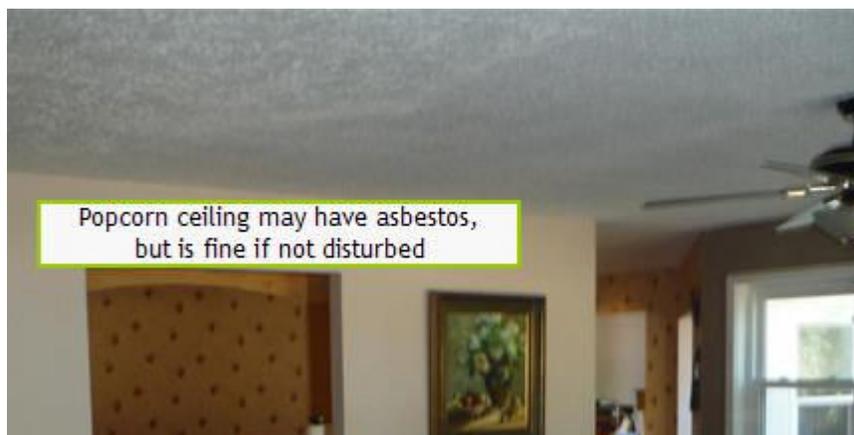
(4) Observed that this home has popcorn ceilings and may contain asbestos given that it was built before 1978 or sometime in the early 1980's (left over inventories were not excluded from asbestos ban). If you want to remove the popcorn to create a smooth ceiling, recommend having your ceiling tested for asbestos first to ensure the renovation is done in a safe manner. Ceilings can be tested via a professional or via a do-it-yourself kit. If you do not plan to remove the popcorn, then the ceiling is consider safe as long as it is not disturbed (such as with repairs, paint, etc.).

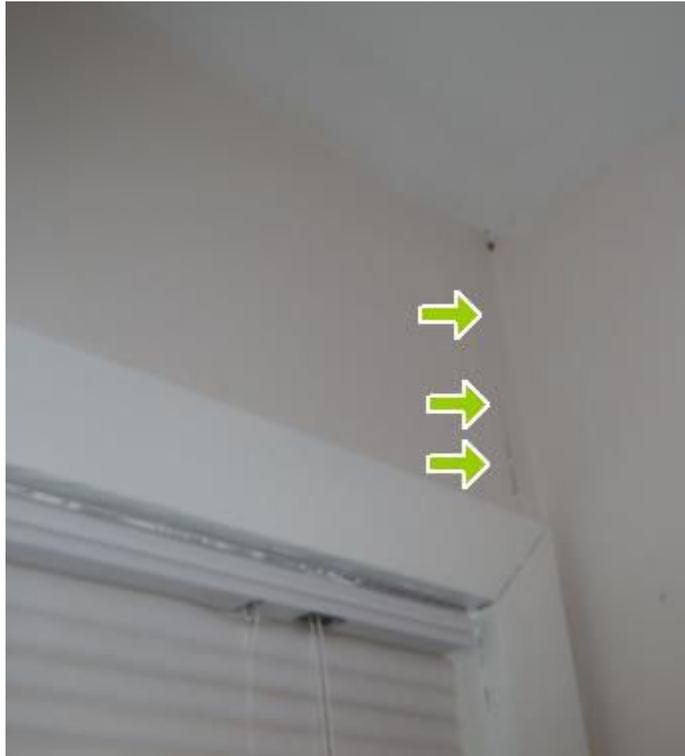
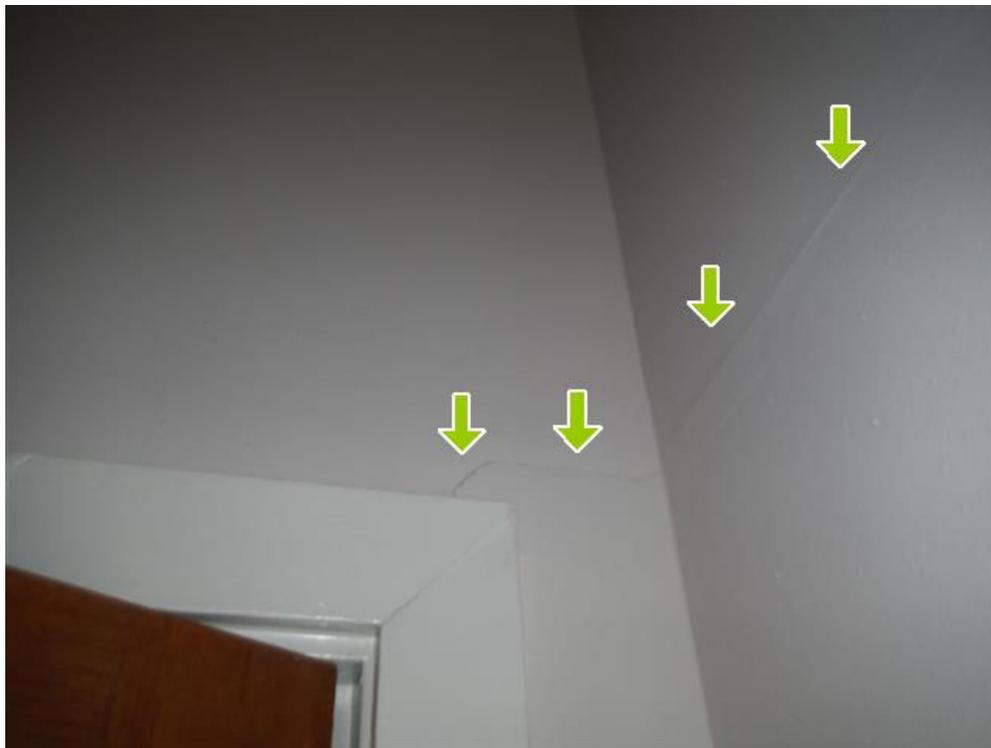
Observed that there are a couple of settlement cracks in the walls -- one just above the right side of a window in one of the bedrooms and the other over the right top of the door frame. Upon inspection, there are no indications of unusual settlement in the home. Upon inspection, there does not appear to be any other indications of unusual settlement (which might indicate an issue with the home's structural integrity). Recommend having a contractor or handyman repair the crack(s) so that the drywall is again in good condition. Then, recommend monitoring the crack over time. If it changes in width or length, the crack will need to be repaired again. Also, new cracking or re-cracking may be cosmetic in nature or could indicate continued movement in an area. *As a result, you may want to consider having a structural engineer evaluate the structural significance of any existing cracks further before closing because foundation repairs can be expensive.*

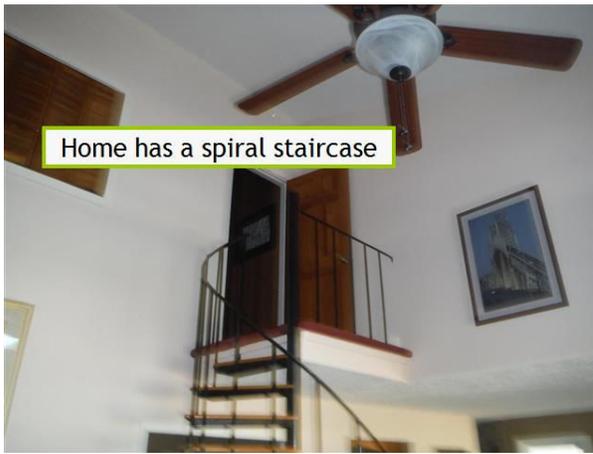
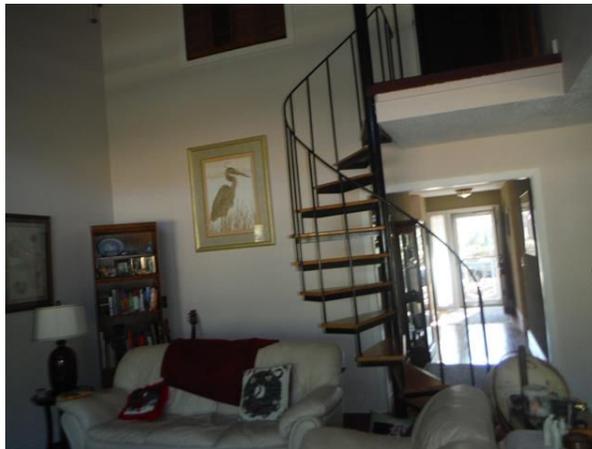
Observed that this home has a spiral staircase. Please note this type of staircase is a safety concern by design as the steps are small, the railings are low and the spindles are too far apart. Recommend using caution. This is an fyi.

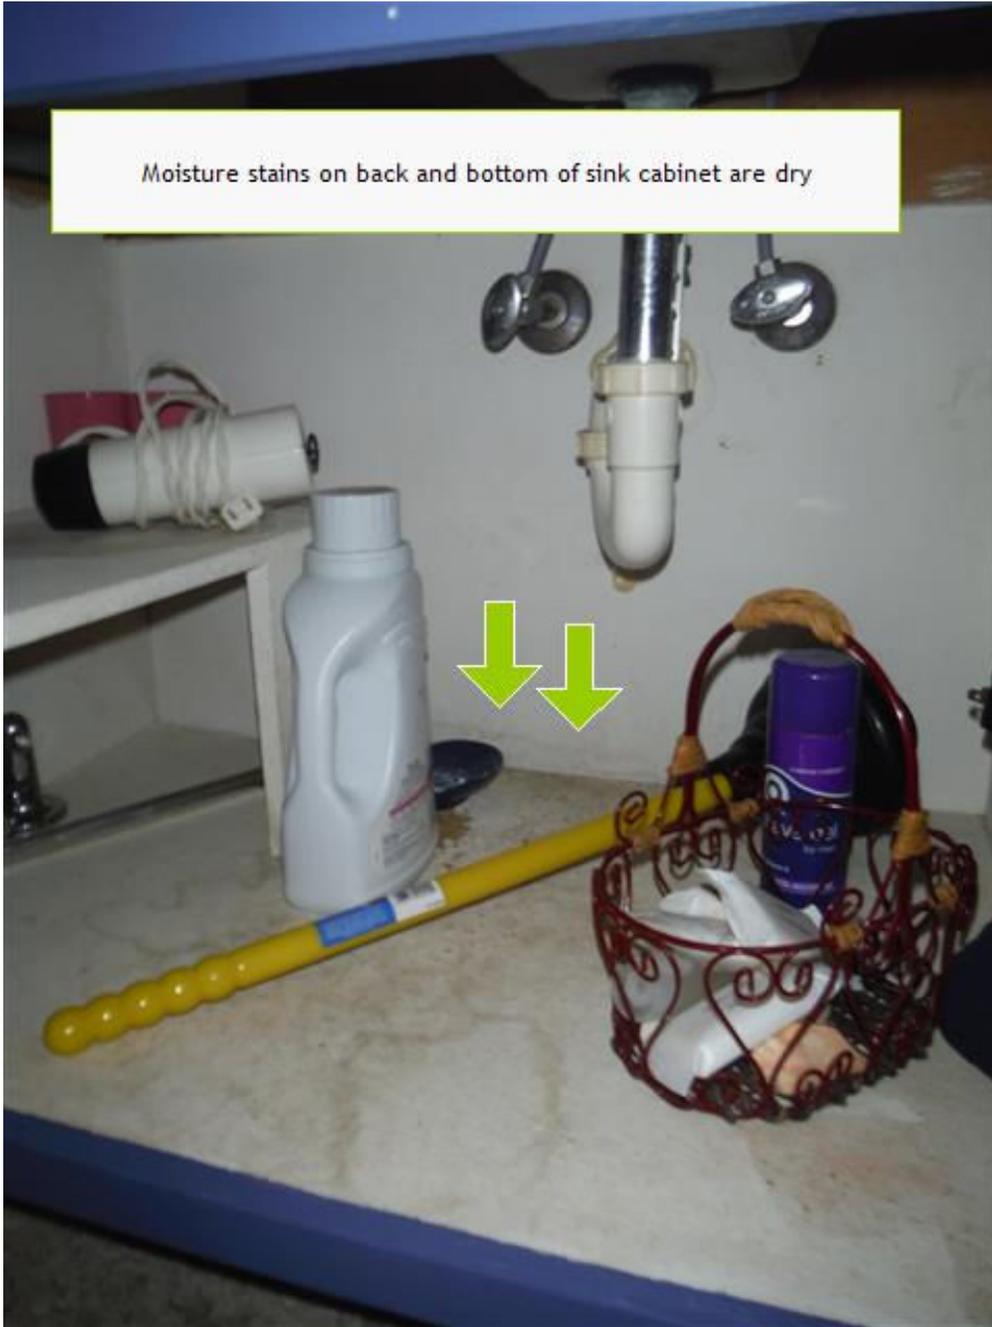
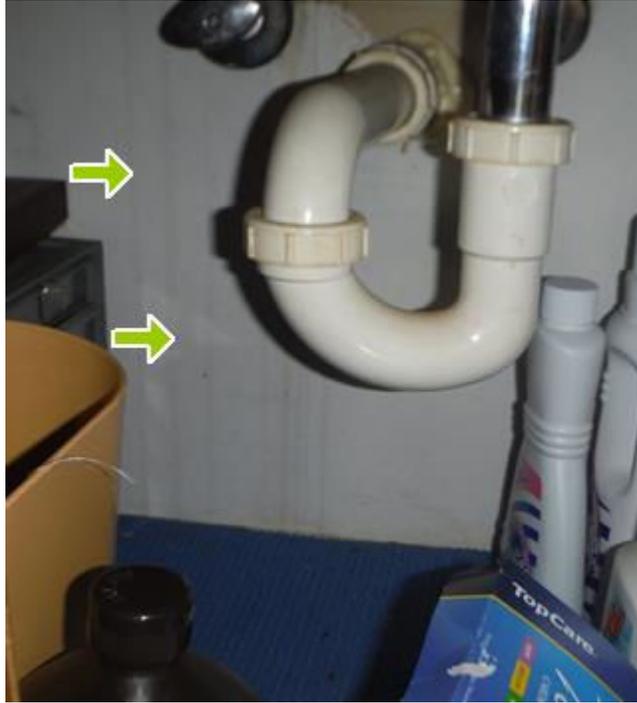
Observed that there are moisture stains inside one or more of the bathroom sink cabinets. Please note that when tested and scanned with an infrared camera, these stains are dry. This is an fyi.
