Home Inspection Report

Prepared for: Sam Wantstosell
Date: 12/15/2014

Property address: 6789 Treehouse Dr.
Summerville SC 29483

Inspected by: Stephen Houmard
Solid Ground Home Inspections
South Carolina License #2046
Certified ASHI® Home Inspector
Infrared-Certified® Home Inspector

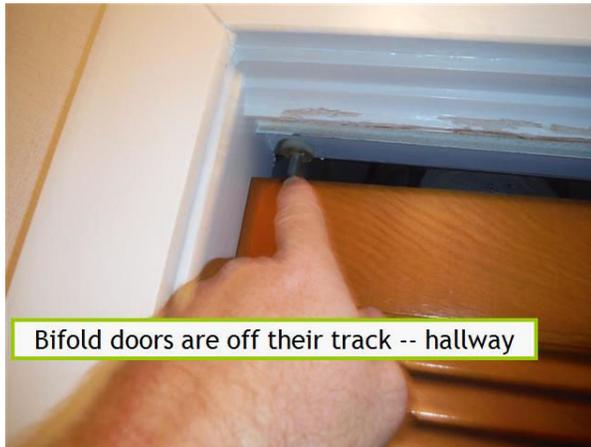
Observed that the bifold doors are off the track in the hallway. Recommend having a handyman re-install the doors so they open and close as they should.

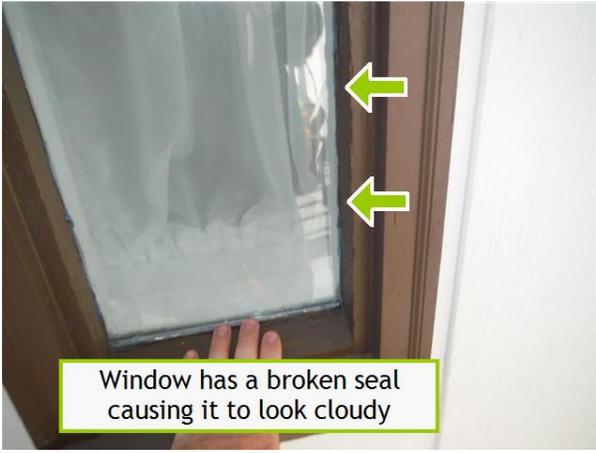
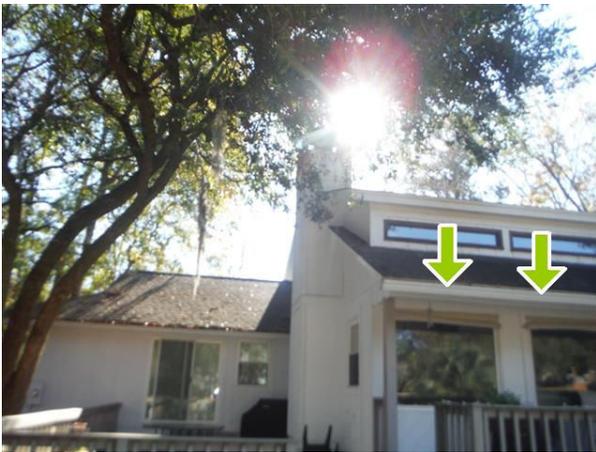
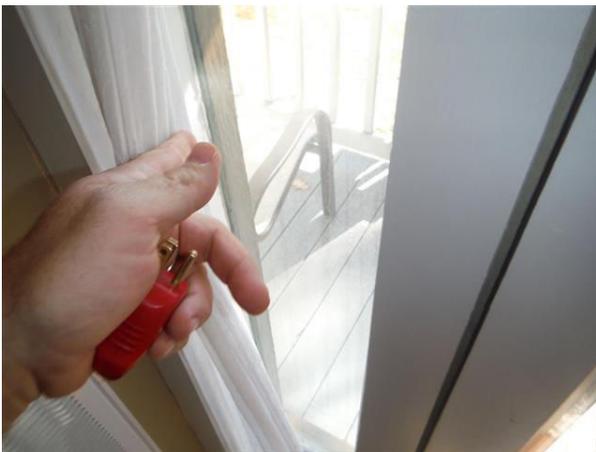
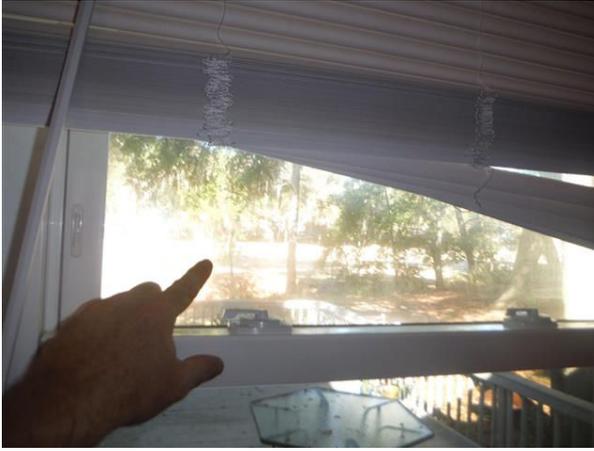
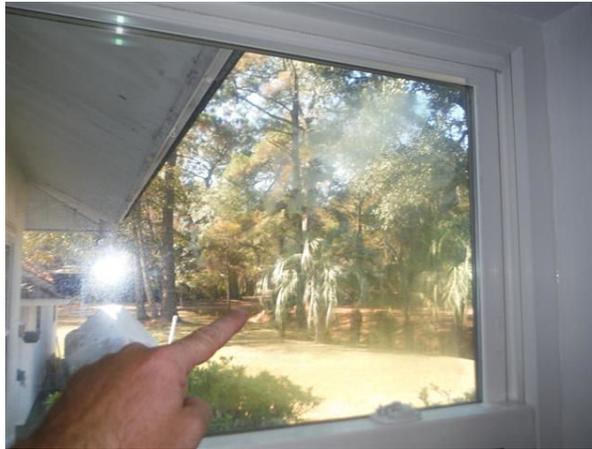
5.6 WINDOWS

Observed that there are eight or more windows which have broken seals causing them to have a cloudy appearance (please see photos for locations). When the seal is broken, moisture seeps in between the panes of glass and causes condensation. Additionally, the insulating properties of the window are significantly reduced so that it acts just like a regular piece of glass. Please note I may not have been able to identify all broken seals -- some are hard to see due to time of day and if the windows are dirty. As a result, recommend having a window contractor evaluate the windows further to ensure all broken seals have been identified, then repair or replace these windows, as needed, so that they again have a clear view to the outside and are insulated to help conserve energy.

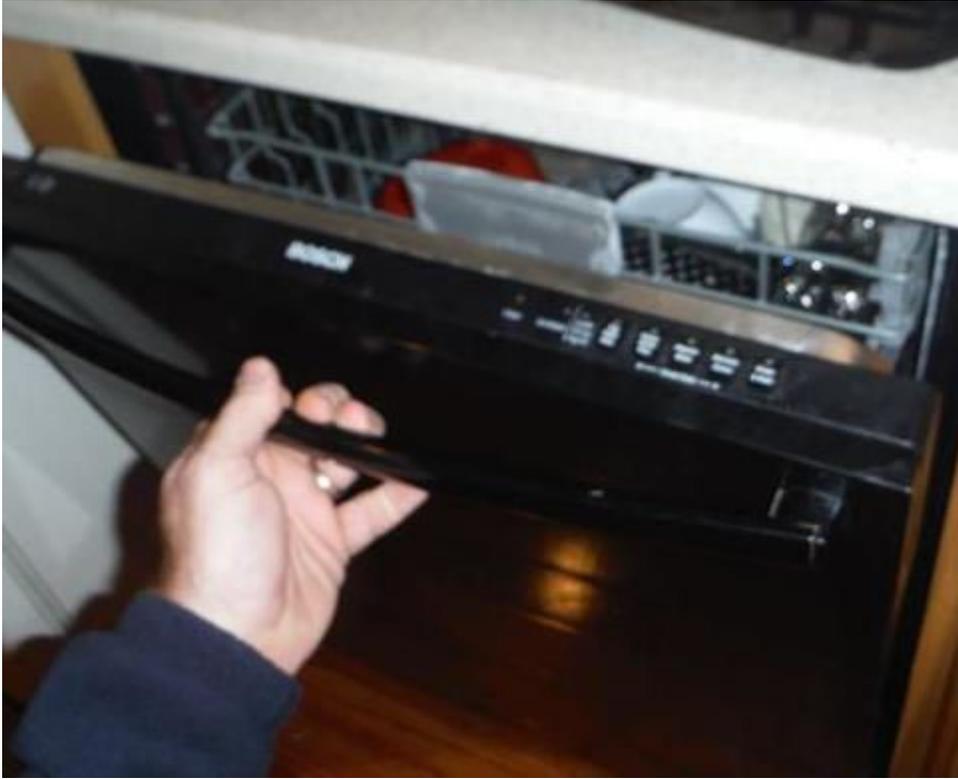
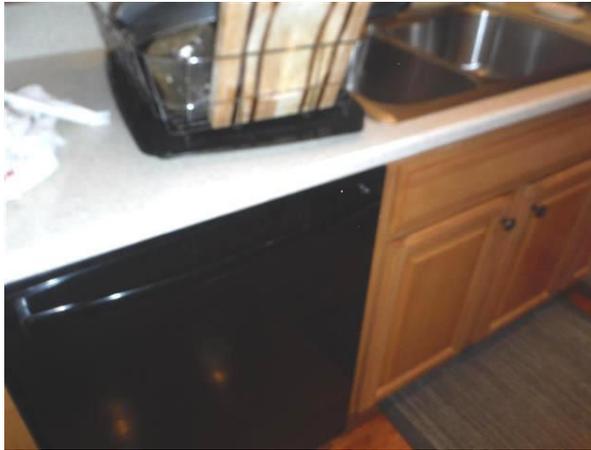
Observed that the dishwasher works when tested -- it was run on rinse cycle to test for leaks. For your reference, the average dishwasher will last about 10 years. Please note its possible the dishwasher is an older model. Due to age, recommend monitoring the dishwasher for possible problems and plan to replace it, when needed. *Since this is an older appliance, also suggest purchasing a 1-year home warranty at closing -- the 90-day limited warranty provided with your inspection does not cover appliances over 10 years old.*

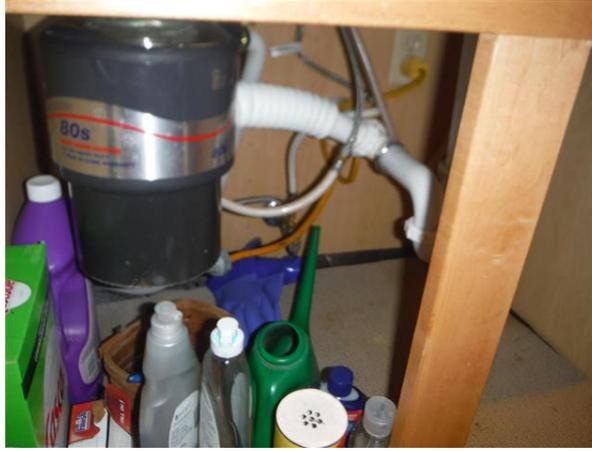
6.1 GARBAGE DISPOSAL

For your reference, the average garbage disposal lasts between 10 and 12 years. Please note its possible the garbage disposal is an older model. Due to age, recommend monitoring the disposal for possible problems and plan to replace it, when needed. *Since this is an older appliance, also suggest purchasing a 1-year home warranty at closing -- the 90-day limited warranty provided with your inspection does not cover appliances over 10 years old.*

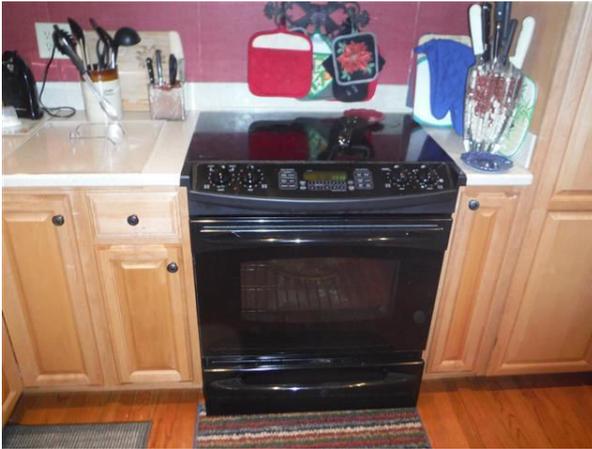
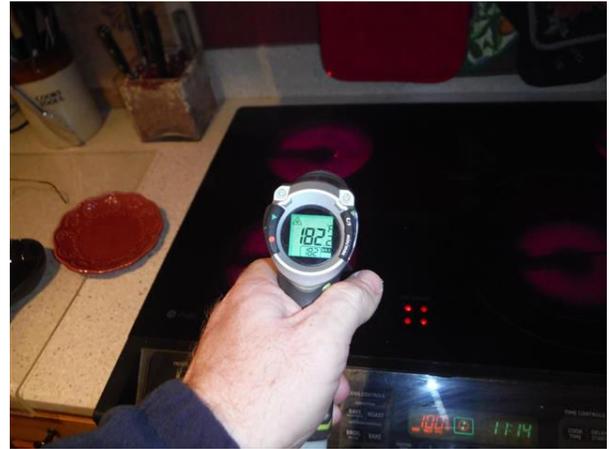
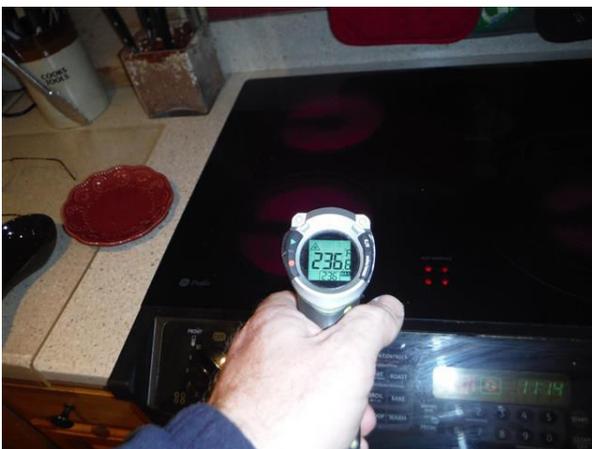
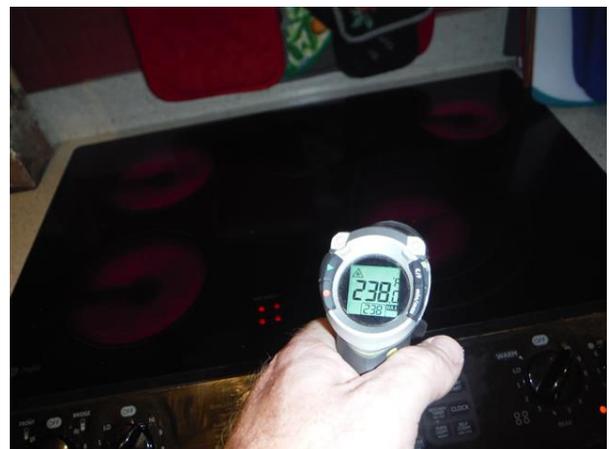
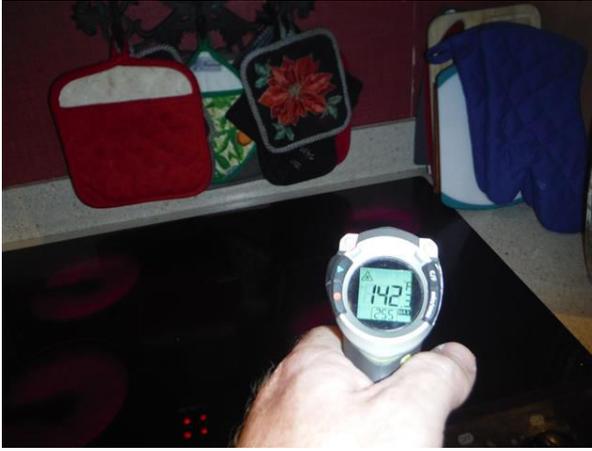
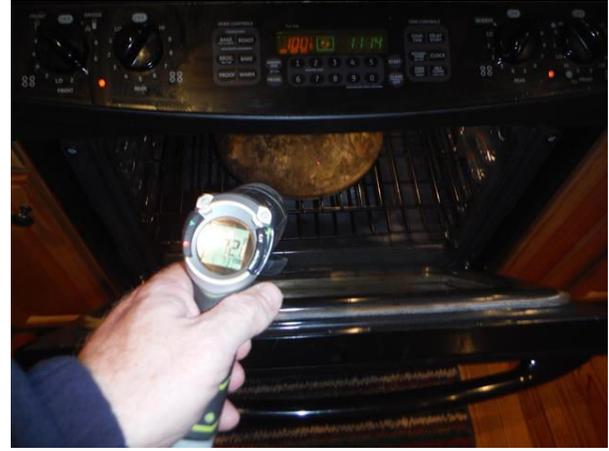
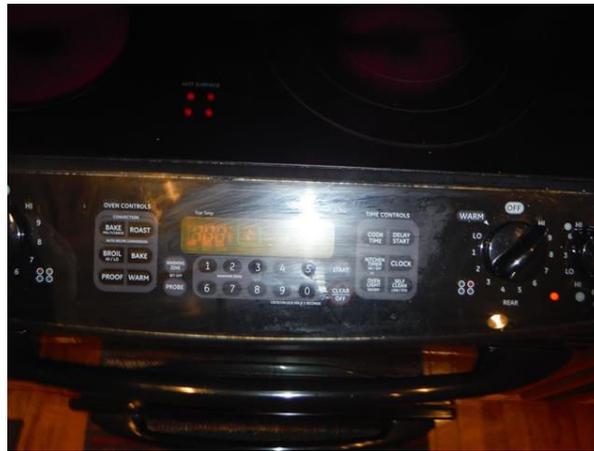
Observed that the oven and cooktop appear to be working well -- they were tested with a infrared red thermometer to ensure they are heating as they should. Please note I did not test for maximum temperature. For your reference, the average electric range will last about 17 years (gas ranges last about 19 years) and the cooktop will last between 13 and 20 years.

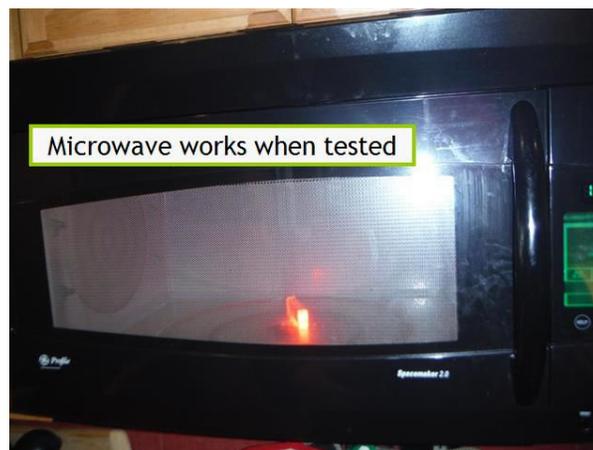
Observed that the microwave appears to be working well -- it was tested with a microwave tester to ensure it is operating properly and that there are no door leaks. For your reference, the average microwave lasts 10 years.

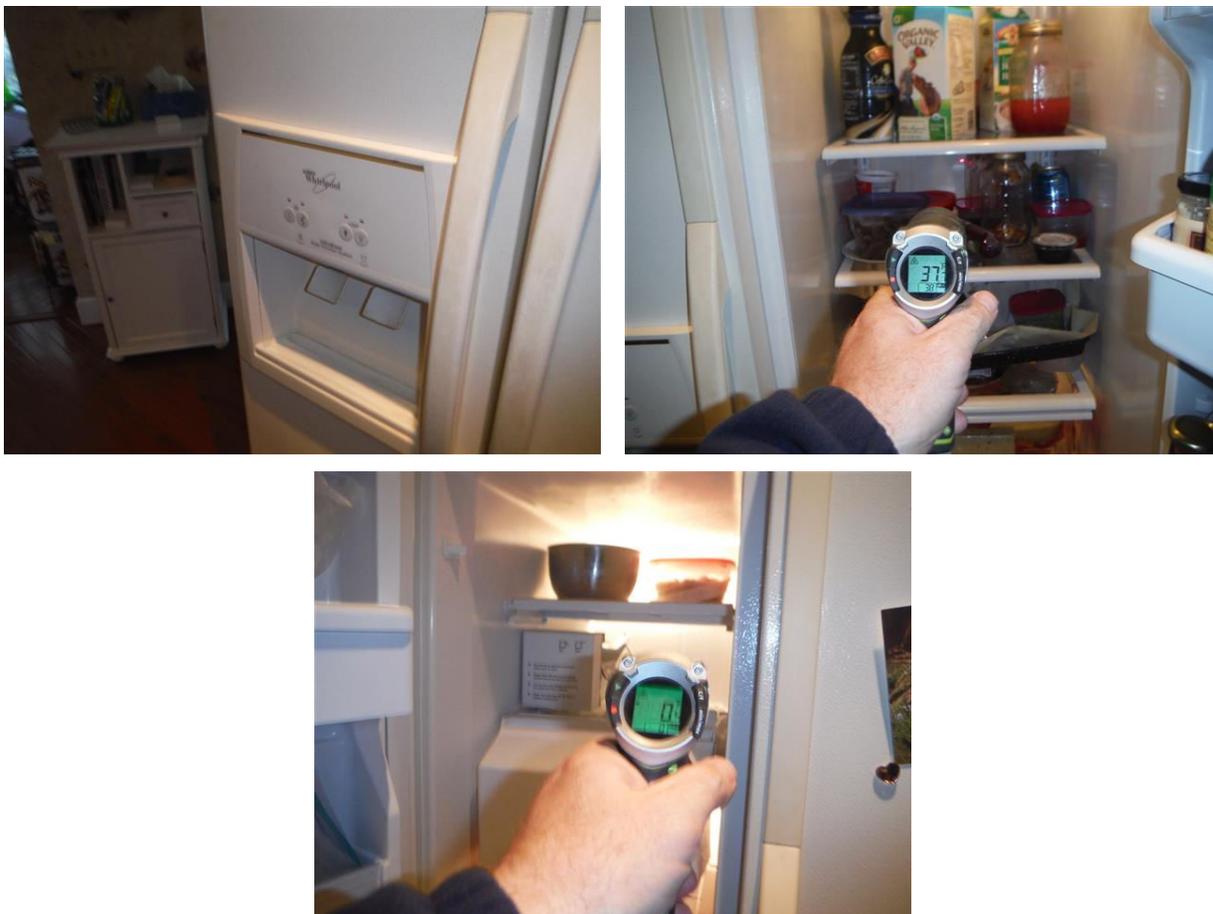
For your reference, the average refrigerator will last between 14 and 19 years. Also, the temperature inside the refrigerator should be kept between 35 and 38 degrees F (and no more than 40 degrees) for food safety. The freezer should be set at 0 degrees F. Due to age, recommend monitoring the refrigerator for possible problems and plan to replace it, when needed. *Since this is an older appliance,*

also suggest purchasing a 1-year home warranty at closing -- the 90-day limited warranty provided with your inspection does not cover appliances over 10 years old.

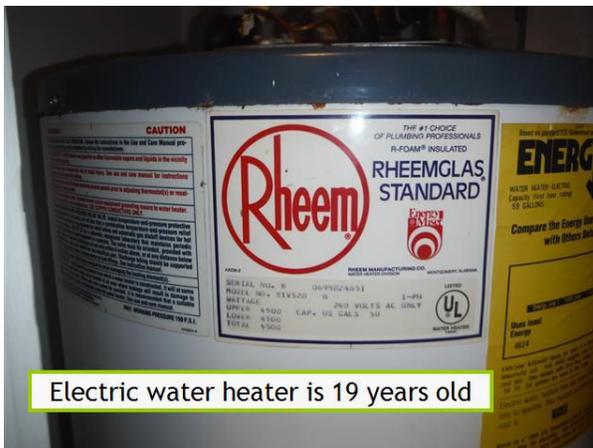
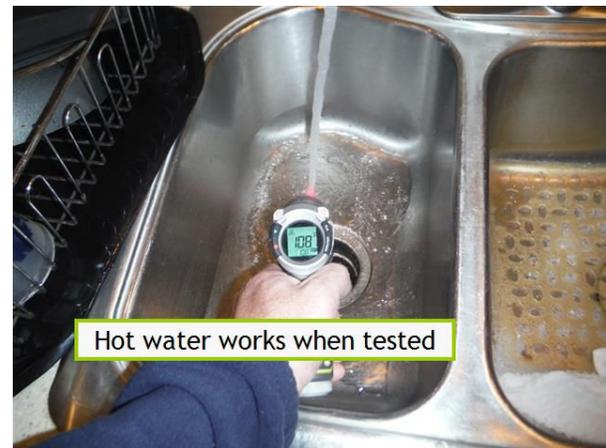
(1) Observed that the electric water heater is 19 years old. Please note the hot water works when tested. For your reference, the average hot water heater lasts about 12 years and sometimes longer. Due to age, recommend monitoring the hot water heater for possible problems or leaks and plan to replace this unit, when needed. *Since this is an older appliance, recommend purchasing a 1-year home warranty at closing -- the 90-day limited warranty provided with this inspection will not cover appliances over 10 years old.*

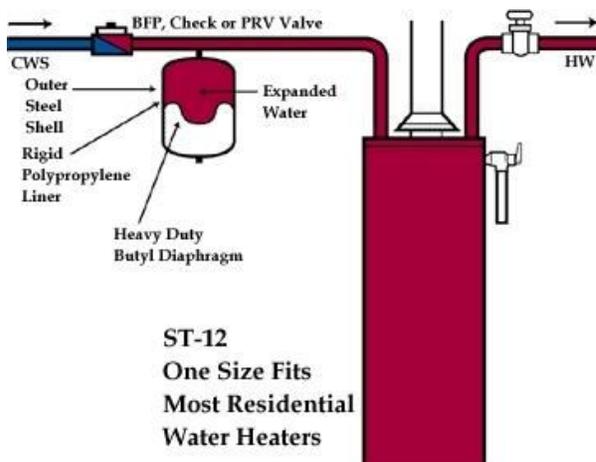
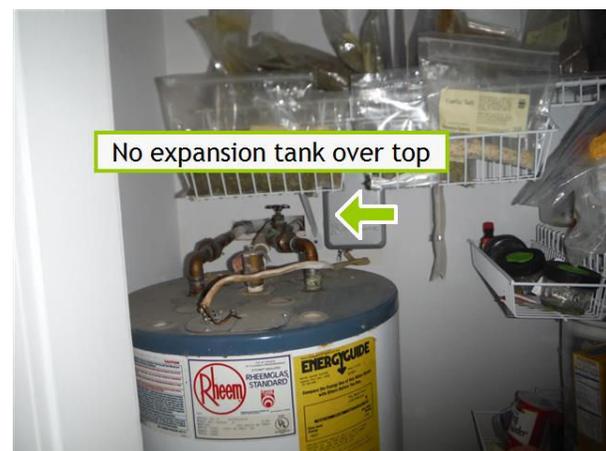
(2) Please note the water heater does not have a thermal expansion tank or earthquake straps. For your reference, an expansion tank is a component which helps to prevent leaks at the TRP (temperature pressure relief) valve. When this unit is replaced, the new heater will have an expansion tank and straps. This is an fyi.

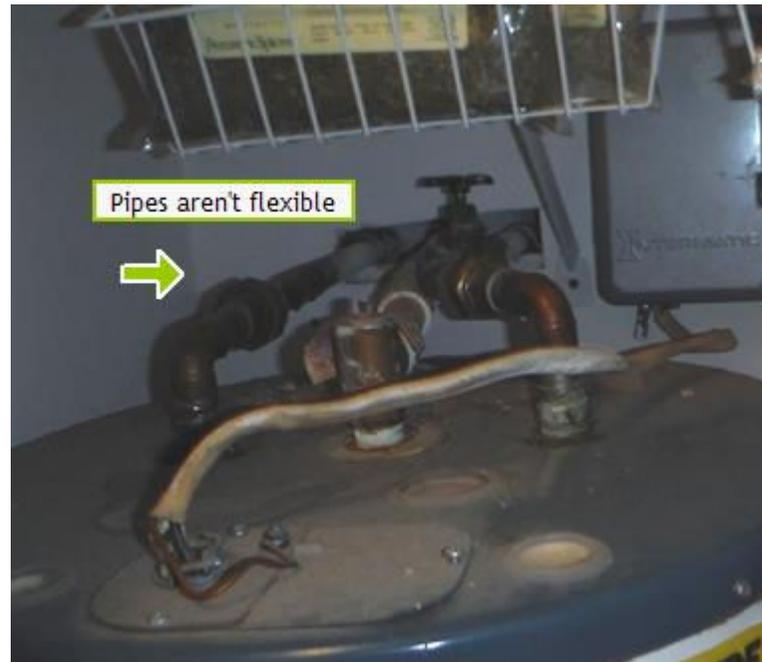
(3) Observed that the plumbing supply pipes which connect to the water heater are not flexible. Ideally, these pipes should be flexible since we are located in an earthquake zone. Recommend having a plumber install flexible pipes in this location when you have a chance.

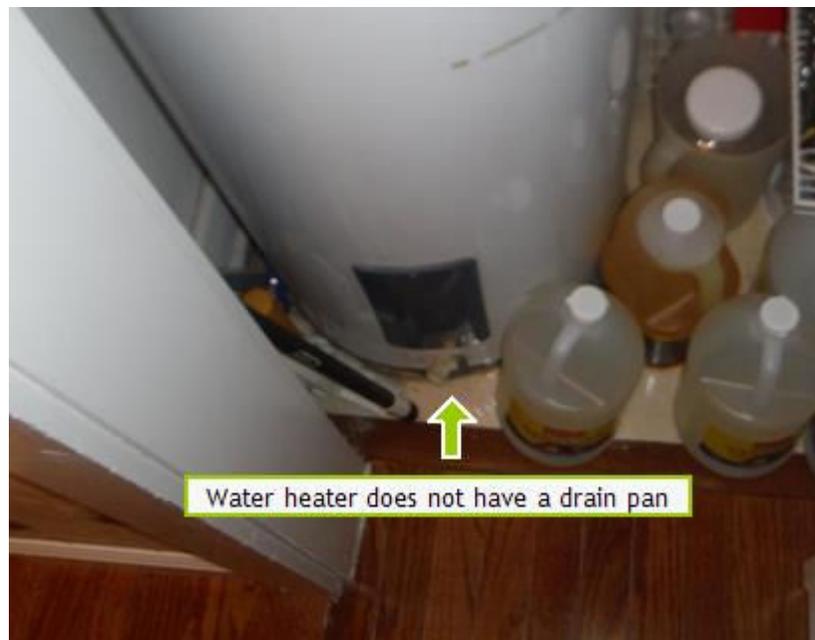
(4) Observed that the water heater does not have a drain pan. Recommend having a plumber install a drain pan.

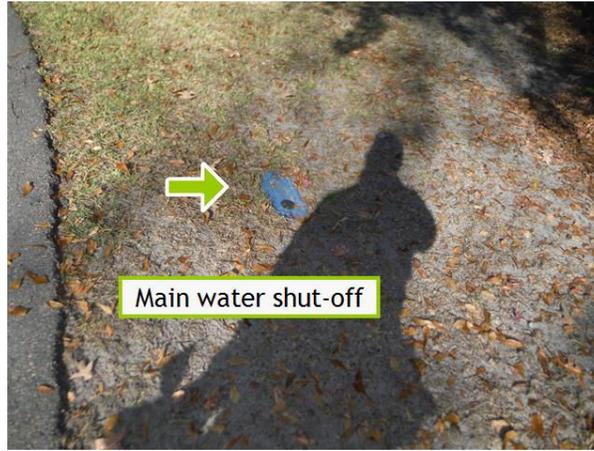
Observed that the main water shut-off is located in the front yard at the meter. If you need to do any plumbing work in the house, or if one of your pipes breaks, you'll need to know where to shut-off the water so repairs can be made. Recommend purchasing a water key at Home Depot or Lowes -- this is an inexpensive item (less than \$10) and will be needed to turn the water on and off.

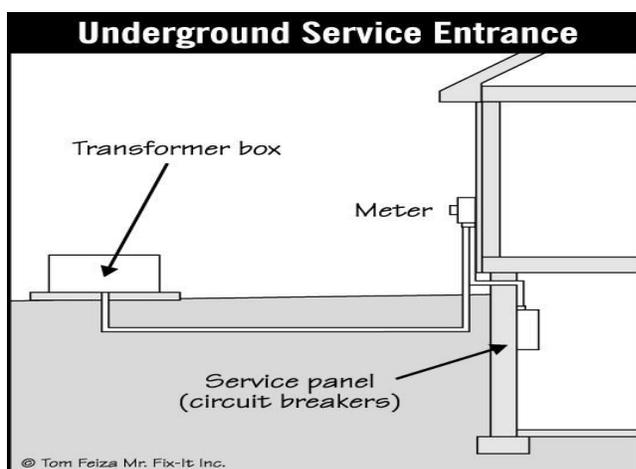
Observed that the underground service entrance conductor (where the power enters the home from the street), electrical meter and grounding rod are in good working condition.

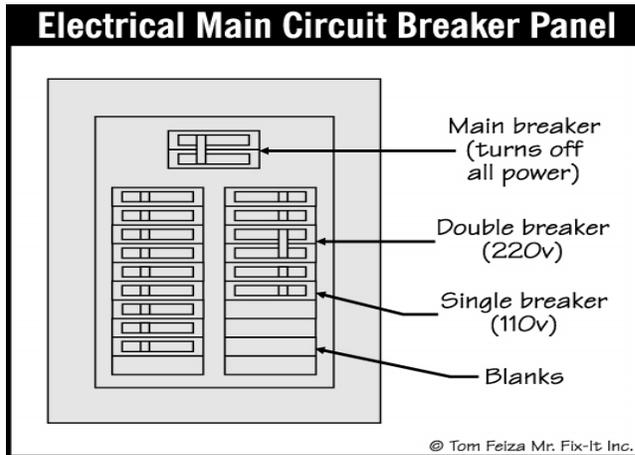
Observed that the main power shut-off (also called the main breaker) is located on the electrical panel. It is helpful to know where the main breaker is in case you need to turn off the power for the whole home.

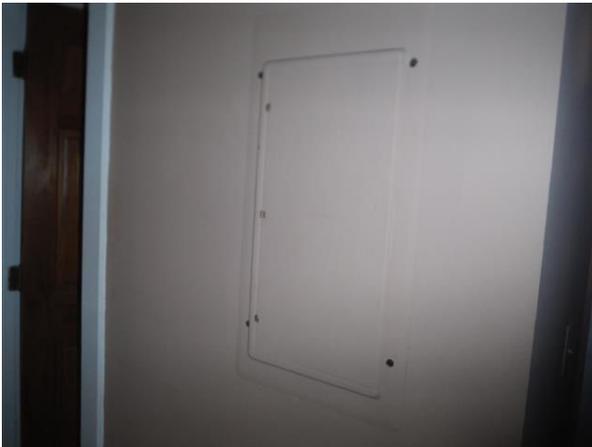
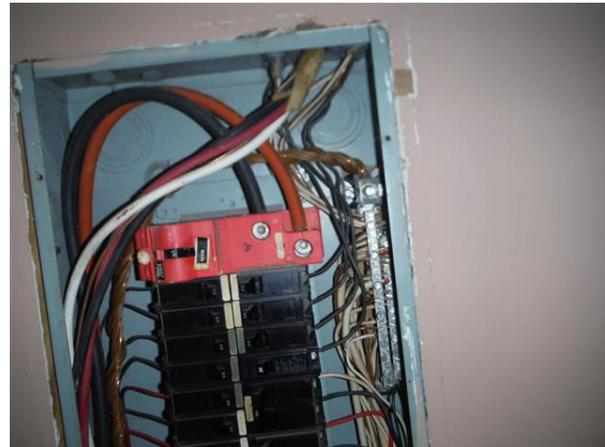
(1) Observed that the inside of the electrical panel is in good condition.

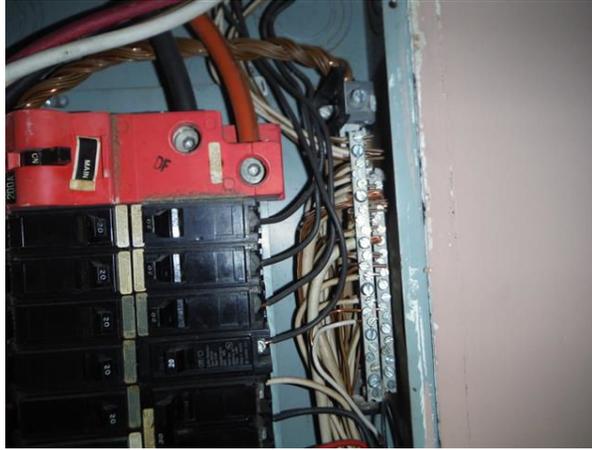
(2) Observed that one or more of the ground and neutral conductors in the main electrical panel are attached together ("double-lugged") under the same lug/screw. Please note this is an outdated industry practice. Instead, all neutral conductors within the panel should be isolated from the ground conductor according to present industry practices, i.e. 'one wire, one screw'. Recommend having an electrician

make the needed repairs so the ground and neutral conductors are properly installed when you have a chance, for safety.

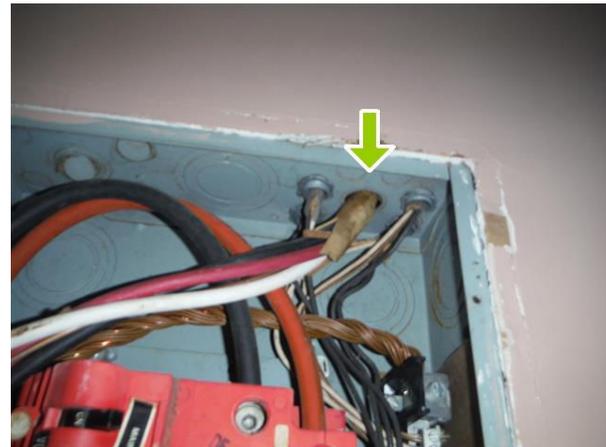
(3) Observed that one or more of the cord strain relievers in the electrical panel are missing. For your reference, the purpose of a cord strain reliever is to prevent electrical wires from being pulled out the bottom of the panel or becoming frayed and to keep pests from entering the panel. Recommend having an electrician install cord strain relievers, where needed, for safety.

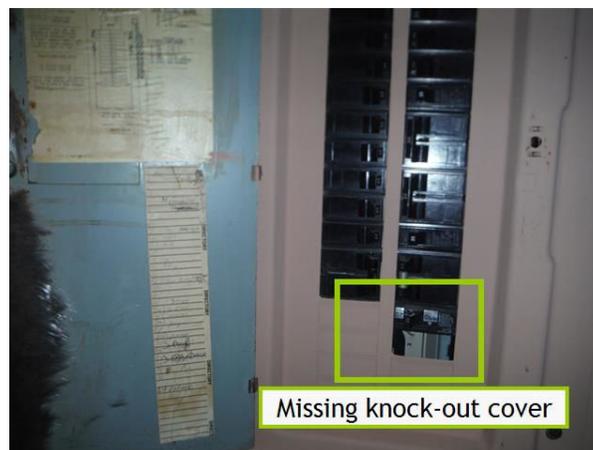
(4) Observed that one or more knock-out cover(s) is missing in the electrical panel which presents a safety hazard. Recommend replacing this cover with a new one -- this is an inexpensive item which can be purchased at the local hardware store.

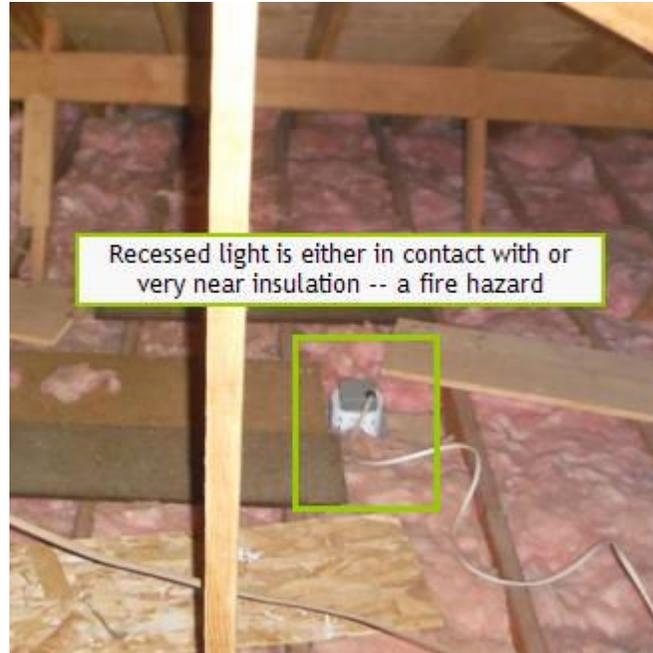
(1) Observed that there is one or more canned/recessed lights in the attic which have insulation on top of them/in direct contact with them -- this is a fire hazard. Please note that these lights can get very hot. Recommend having a handyman move the insulation away from the lights so there is sufficient clearance all the way around and on top of these fixtures, where needed, for safety.

(1) Observed that there is one or more canned/recessed lights in the attic which have insulation on top of them/in direct contact with them -- this is a fire hazard. Please note that these lights can get very hot. Recommend having a handyman move the insulation away from the lights so there is sufficient clearance all the way around and on top of these fixtures, where needed, for safety.

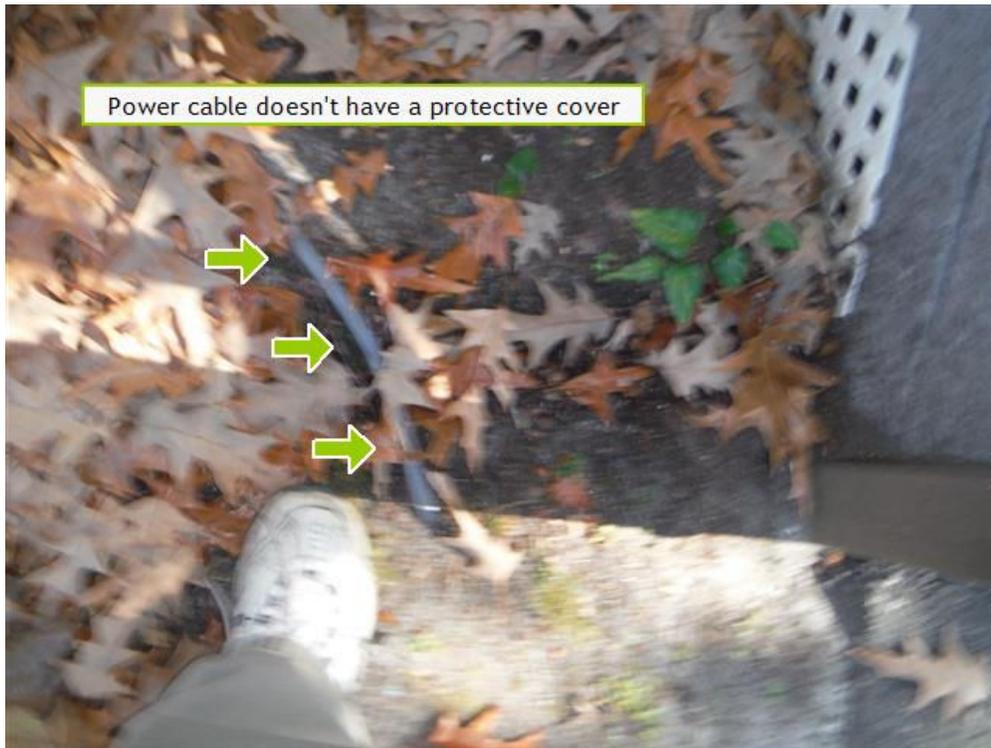
(2) Observed the electrical wire which runs from the home to the garage along the ground is UV-protected, but some of the wire is not in a plastic conduit for protection. Recommend having an electrician properly encase this electrical wire, for safety.

(2) Observed the electrical wire which runs from the home to the garage along the ground is UV-protected, but some of the wire is not in a plastic conduit for protection. Recommend having an electrician properly encase this electrical wire, for safety.

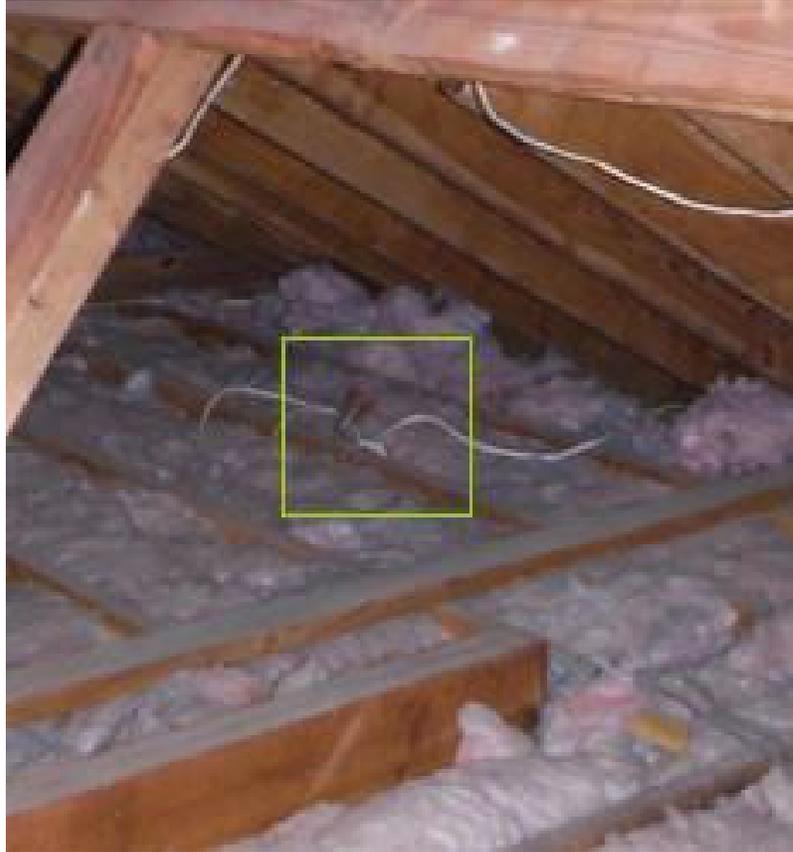
(3) Observed that there is a wire connection in the attic which is not enclosed in an electrical box. Recommend having an electrician enclose this connection in an electrical/junction box with a cover for safety.

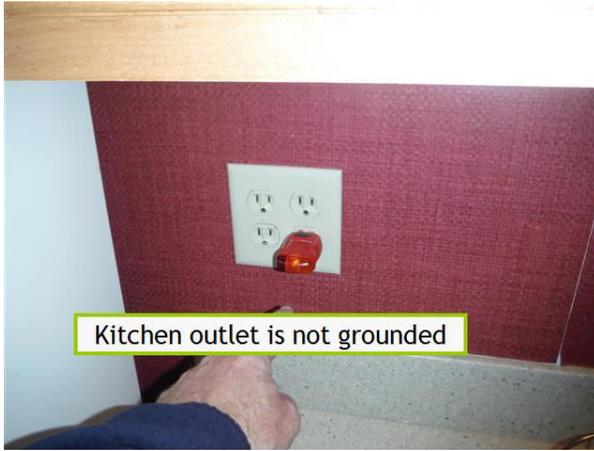
(1) Observed that one or more of the electrical outlets in the kitchen, another one or two in the guest bedroom, a couple in the hallway and one in the family room are not grounded. Recommend having an electrician make the needed repairs so these outlets are properly grounded, for safety.

Kitchen outlet is not grounded

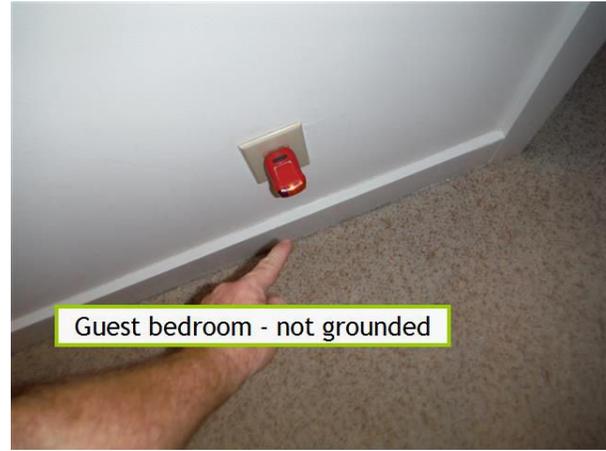
Guest bedroom - not grounded

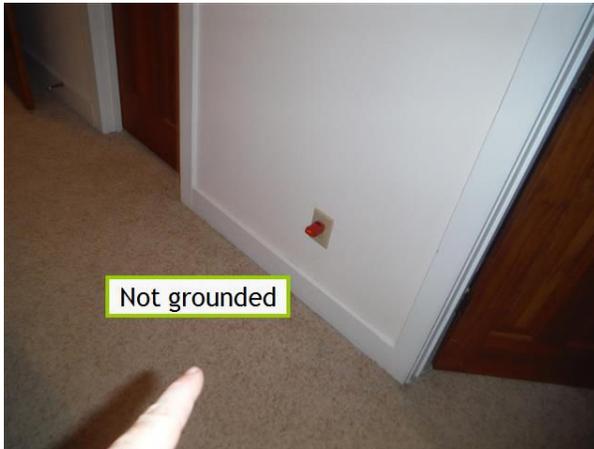
Not grounded

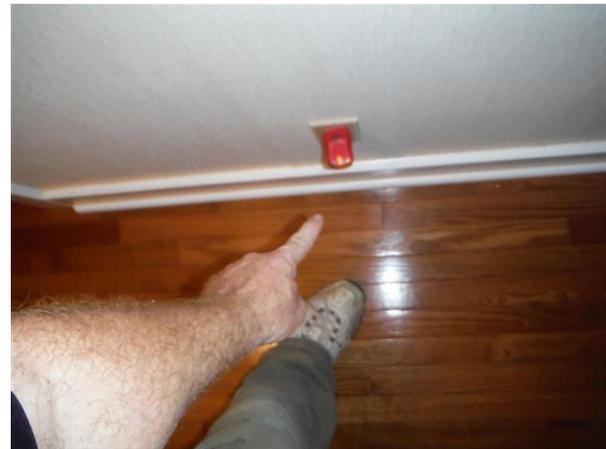
Family room outlet -- not grounded

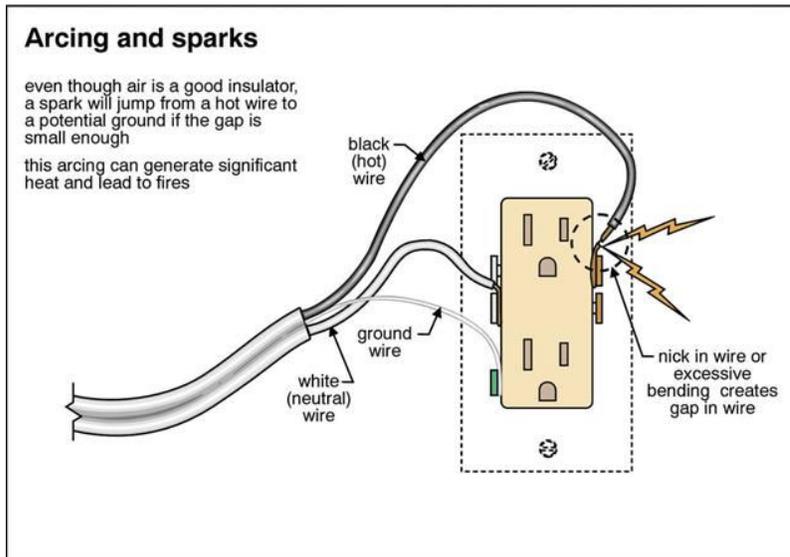
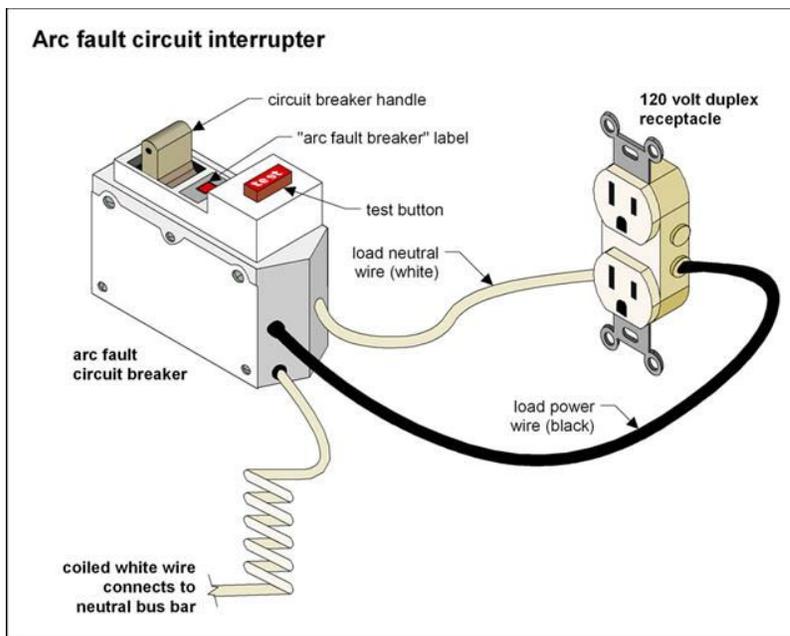
Observed that this home does not have Arc Fault Circuit Interrupters (AFCI's) -- this is common for a home of this age. For your reference, this is a type of electrical outlet with a safety device designed to prevent fire hazards. In contrast, GFCI outlets are designed to prevent electric shock hazards. All homes built in 2014 are required to have AFCI outlets in every interior living space except where there is a GFCI. Older homes built in the last ten years or so were only required to have them in the bedrooms. Homes older than this likely do not have them at all. As a result, recommend having an electrician install AFCI outlets in your living spaces, except where a GFCI is needed/exists, when you have a chance, for safety.

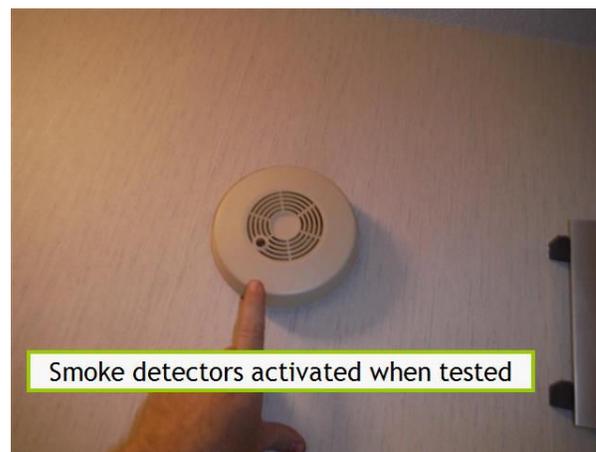
(1) Observed that this home has smoke detectors which activated when tested. *If you don't know how old your smoke detector is, or if it is 10 years old or more, suggest replacing it as soon as possible to ensure that it works when it needs to, for safety.*

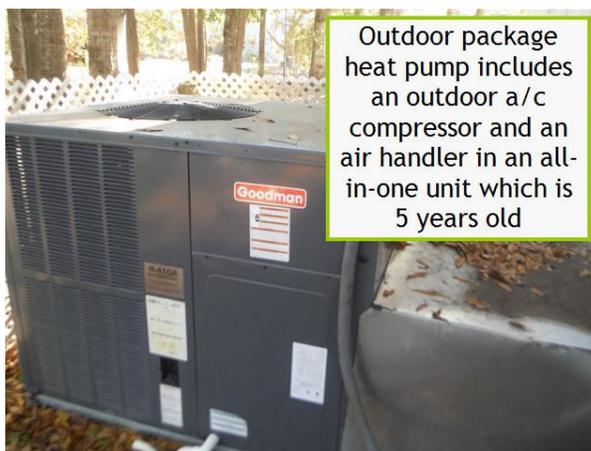
(1) Observed that there is an outdoor package heat pump (a/c compressor and air handler in one piece of equipment) to heat and cool the the home. Please note this unit is 5 years old. For your reference, outdoor heat pumps generally last up to 12 years and sometimes longer with good maintenance.

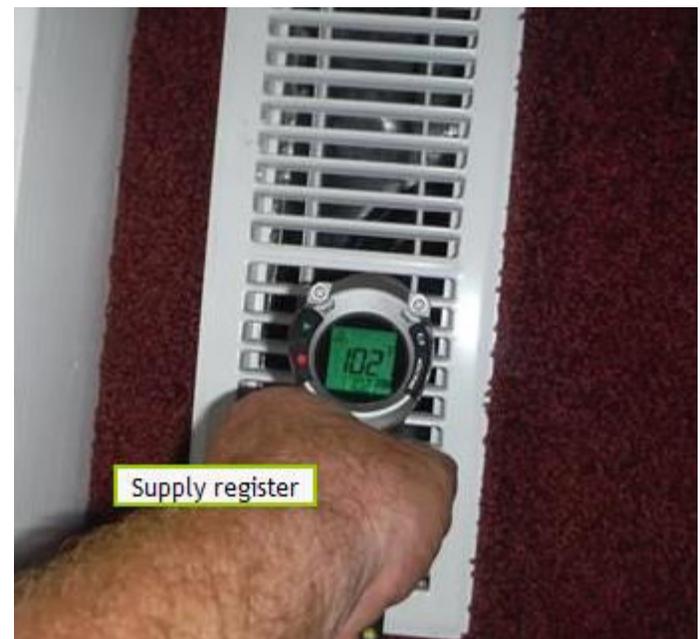
(1) When tested, it appears that the heat is working well. For your reference, there should be at least a 14 degree difference between the air at the return register and where the heated air enters the home at the supply register to indicate normal functioning. In this case, there was a 31 degree difference. Please note the air conditioning was not tested since the outside temperature was below 65 degrees to prevent possible damage to the a/c compressor(s).

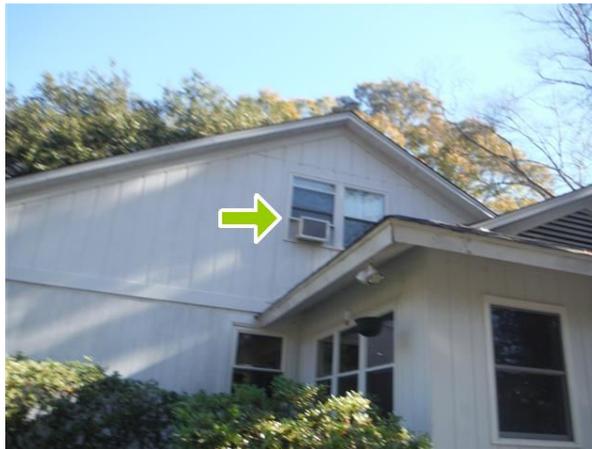
Observed the room over the kitchen is not part of the central HVAC system. Instead, this room uses a built-in portable window unit.

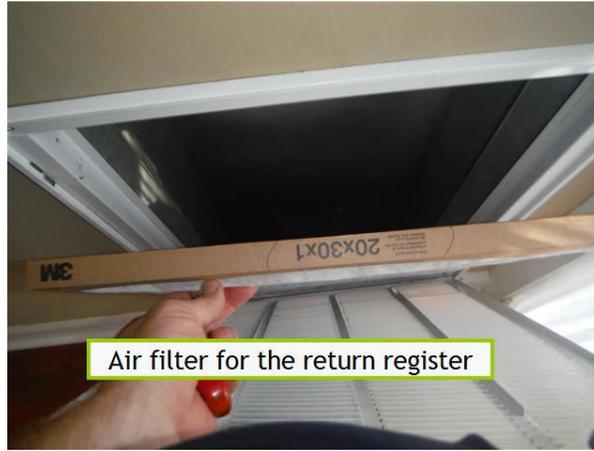
Observed that the size of the air filters for the return registers are 20 X 30.

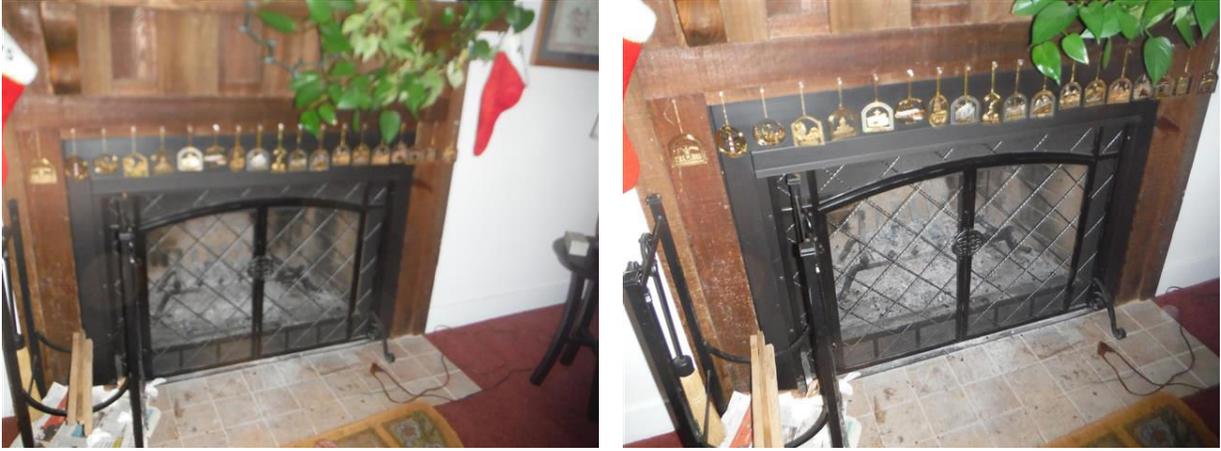
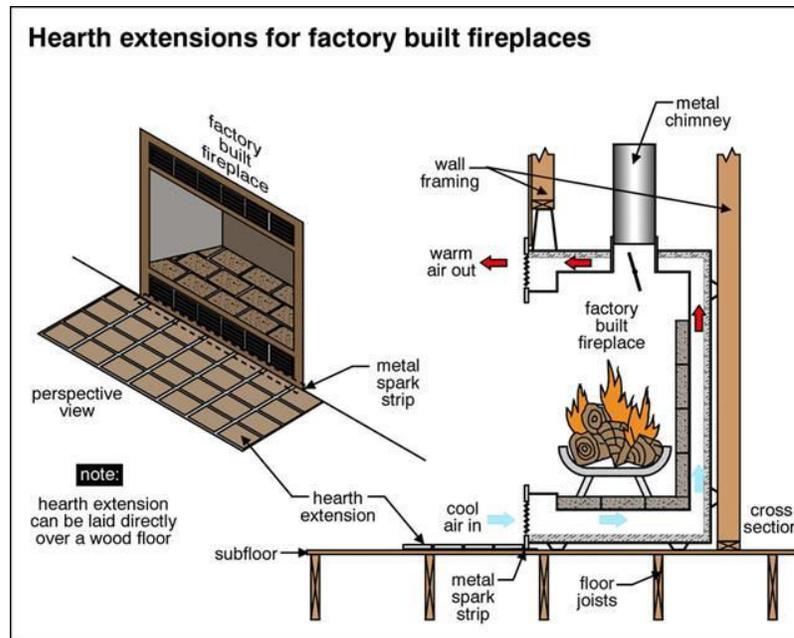
Observed that this home has a metal insert, wood-burning fireplace.

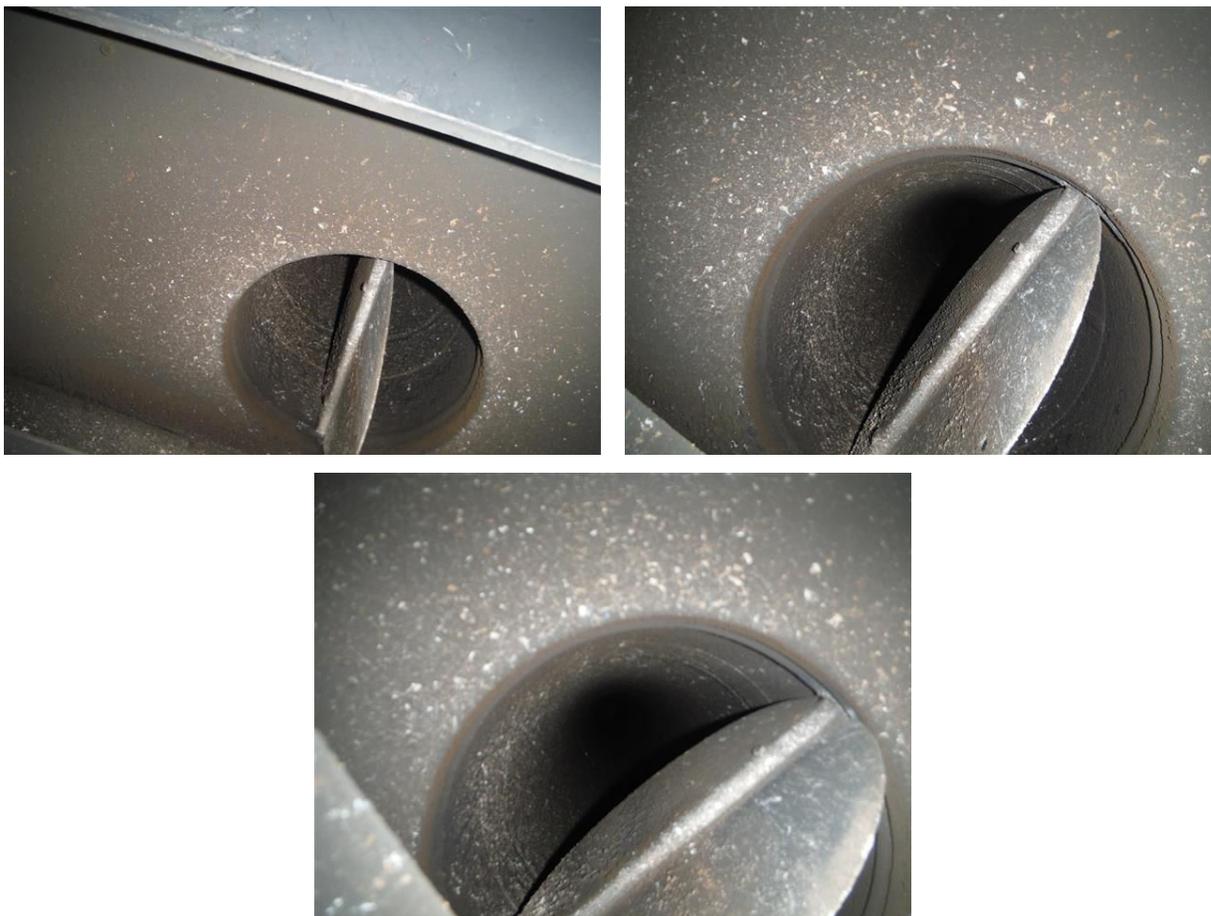
Observed that the chimney or chimney liner appears to be in good condition. Please note there is some, but not a lot, of creosote build-up which can be a fire hazard and may also conceal hairline cracks. As a safety precaution, we generally suggest having a chimney sweep clean the liner to remove the build-up. Build-up which is 1/8" deep or more should be cleaned. With the build-up removed, then have the chimney sweep or fireplace contractor inspect the chimney or liner further to ensure it is in good condition before a fire is made in the fireplace.

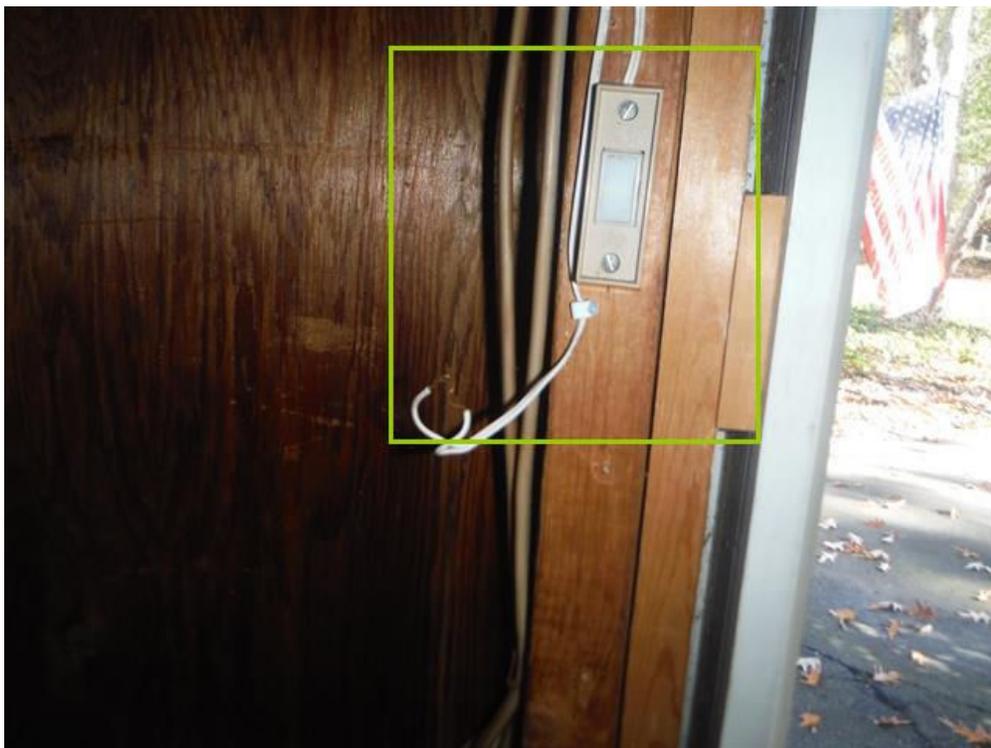
(1) Observed the auto garage door opener is missing a button inside the garage. Please note there are two wires used to open and close the door. Recommend repair.

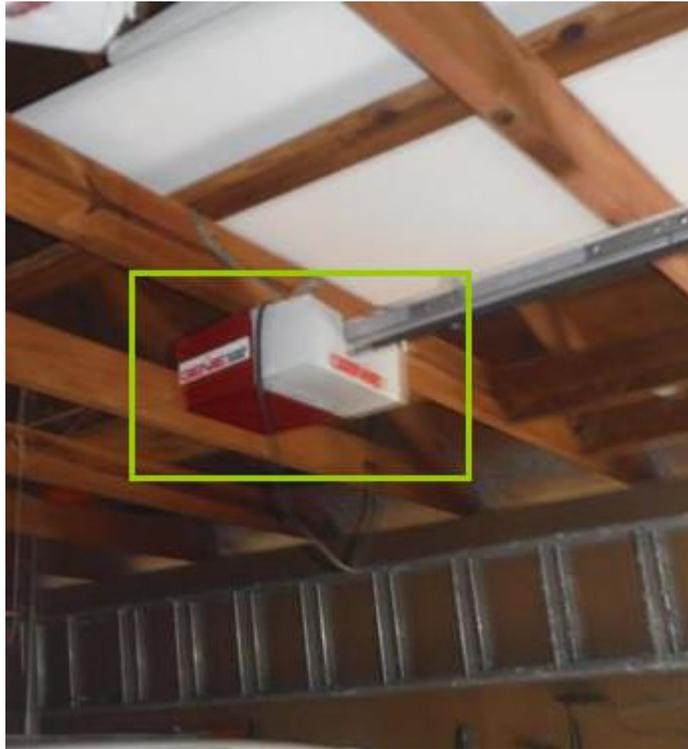
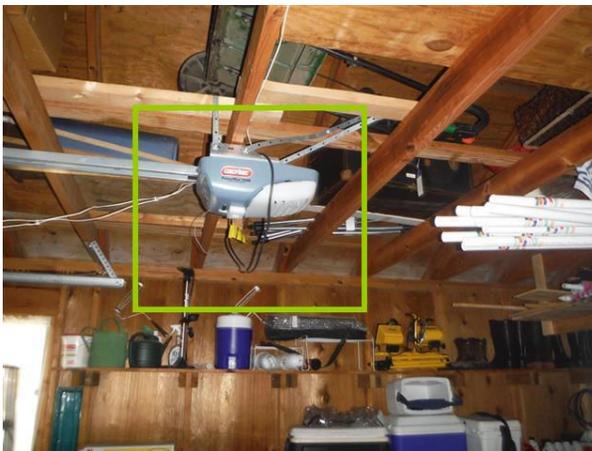
(2) Observed that this home has two automatic garage door openers in good working order. For your reference, there are three basic safety features on your garage door that should periodically be tested, ideally once a month:
